KWM-380 TRANSCEIVER (622-5093-101)  
HF-380 TRANSCEIVER (622-3580-101)  
RECEIVER-EXCITER CIRCUIT CARD A3 (638-6908-001)

**SERVICE BULLETIN NO 1****PRODUCT IMPROVEMENT**

KWM-380 TRANSCEIVER (622-5093-001, -101)  
HF-380 TRANSCEIVER (622-3580-001, -101)  
SYNTHESIZER A5A1 (638-6916-001, -002)

## SERVICE BULLETIN NO 2

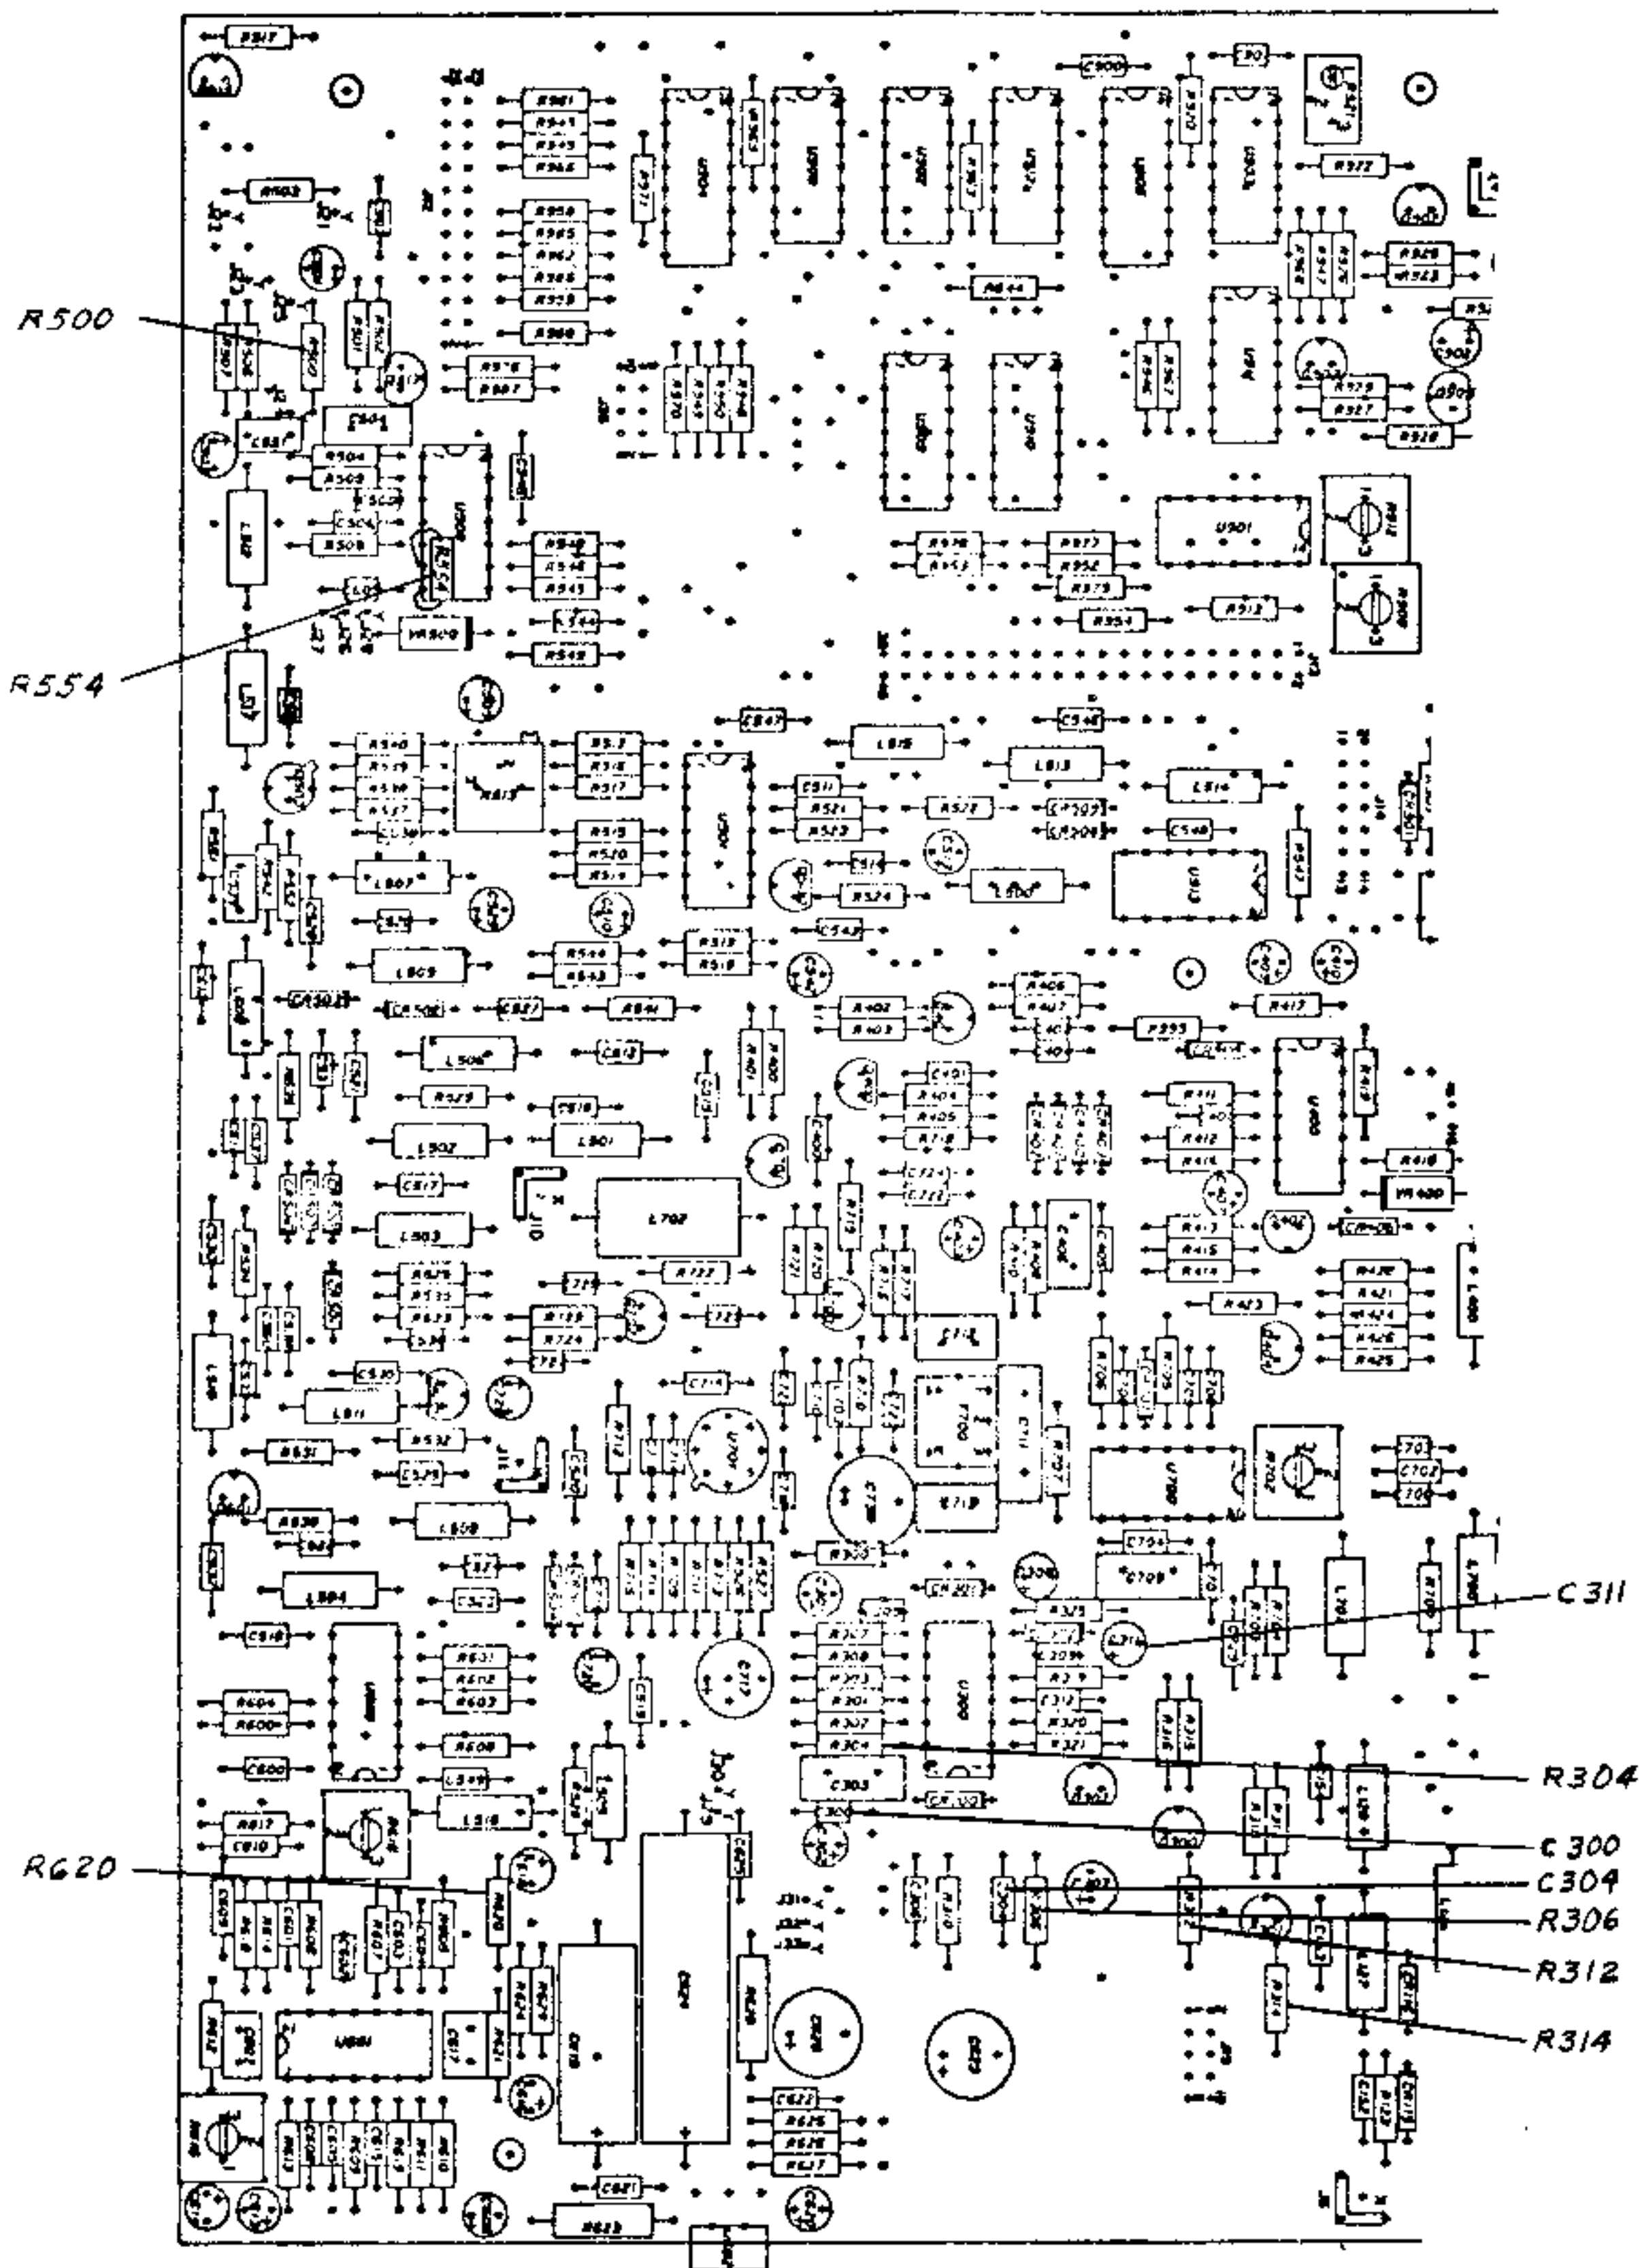
P/O Receiver/Exciter Circuit Card A3  
Figure 1

1. Mic termination is changed from 270- $\Omega$  to 3.3-k  $\Omega$  to allow either a low- or high-impedance mic to be used.
2. Mic gain is increased by approximately 18 dB.
3. A greater range of adjustment for VOX sensitivity is provided.
4. Minimum VOX delay time is decreased to less than 50 ms to allow faster semibreak in CW operation.
5. Preemphasis to VOX preamplification is added to improve SSB VOX operation.
6. Line audio (600  $\Omega$  ) output level is increased to ensure at least -10-dBm output.

All changes are on the receiver-exciter circuit card. The changes consist of replacing 7 resistors and 3 capacitors.

NOTE: All component changes are on the receiver-exciter card A3, located on the bottom of the chassis. Refer to figure 1 for location of components on the receiver-exciter card.

- C. Remove 100-k  $\Omega$  resistor R554 and replace it with a 1-M  $\Omega$  resistor (745-2449-000).
- D. Remove 270-  $\Omega$  resistor R500 and replace it with a 3.3-k  $\Omega$  resistor (745-0767-000).

- E. Remove 33-k  $\Omega$  resistor R620 and replace it with an 18-k  $\Omega$  resistor (745-0794-000).
- F. Remove 1- $\mu$ F capacitor C311 and replace it with a 0.22- $\mu$ F capacitor (184-9102-310).

- G. Remove 1-M  $\Omega$  resistor R304 and replace it with a 100-k  $\Omega$  resistor (745-0821-000).
- H. Remove 0.01- $\mu$ F capacitor C300 and replace it with a 1000-pF capacitor (913-3281-270).

- I. Remove 0.1- $\mu$ F capacitor C304 and replace it with a 4.7- $\mu$ F capacitor (184-9102-390). The negative lead of the capacitor should be connected to the hole on the left.

- J. Remove 1-k  $\Omega$  resistor R306 and replace it with a 100-  $\Omega$  resistor (745-0713-000).
- K. Remove 47-k  $\Omega$  resistors R312 and R314 and replace them with 10-k  $\Omega$  resistors (745-0785-000).

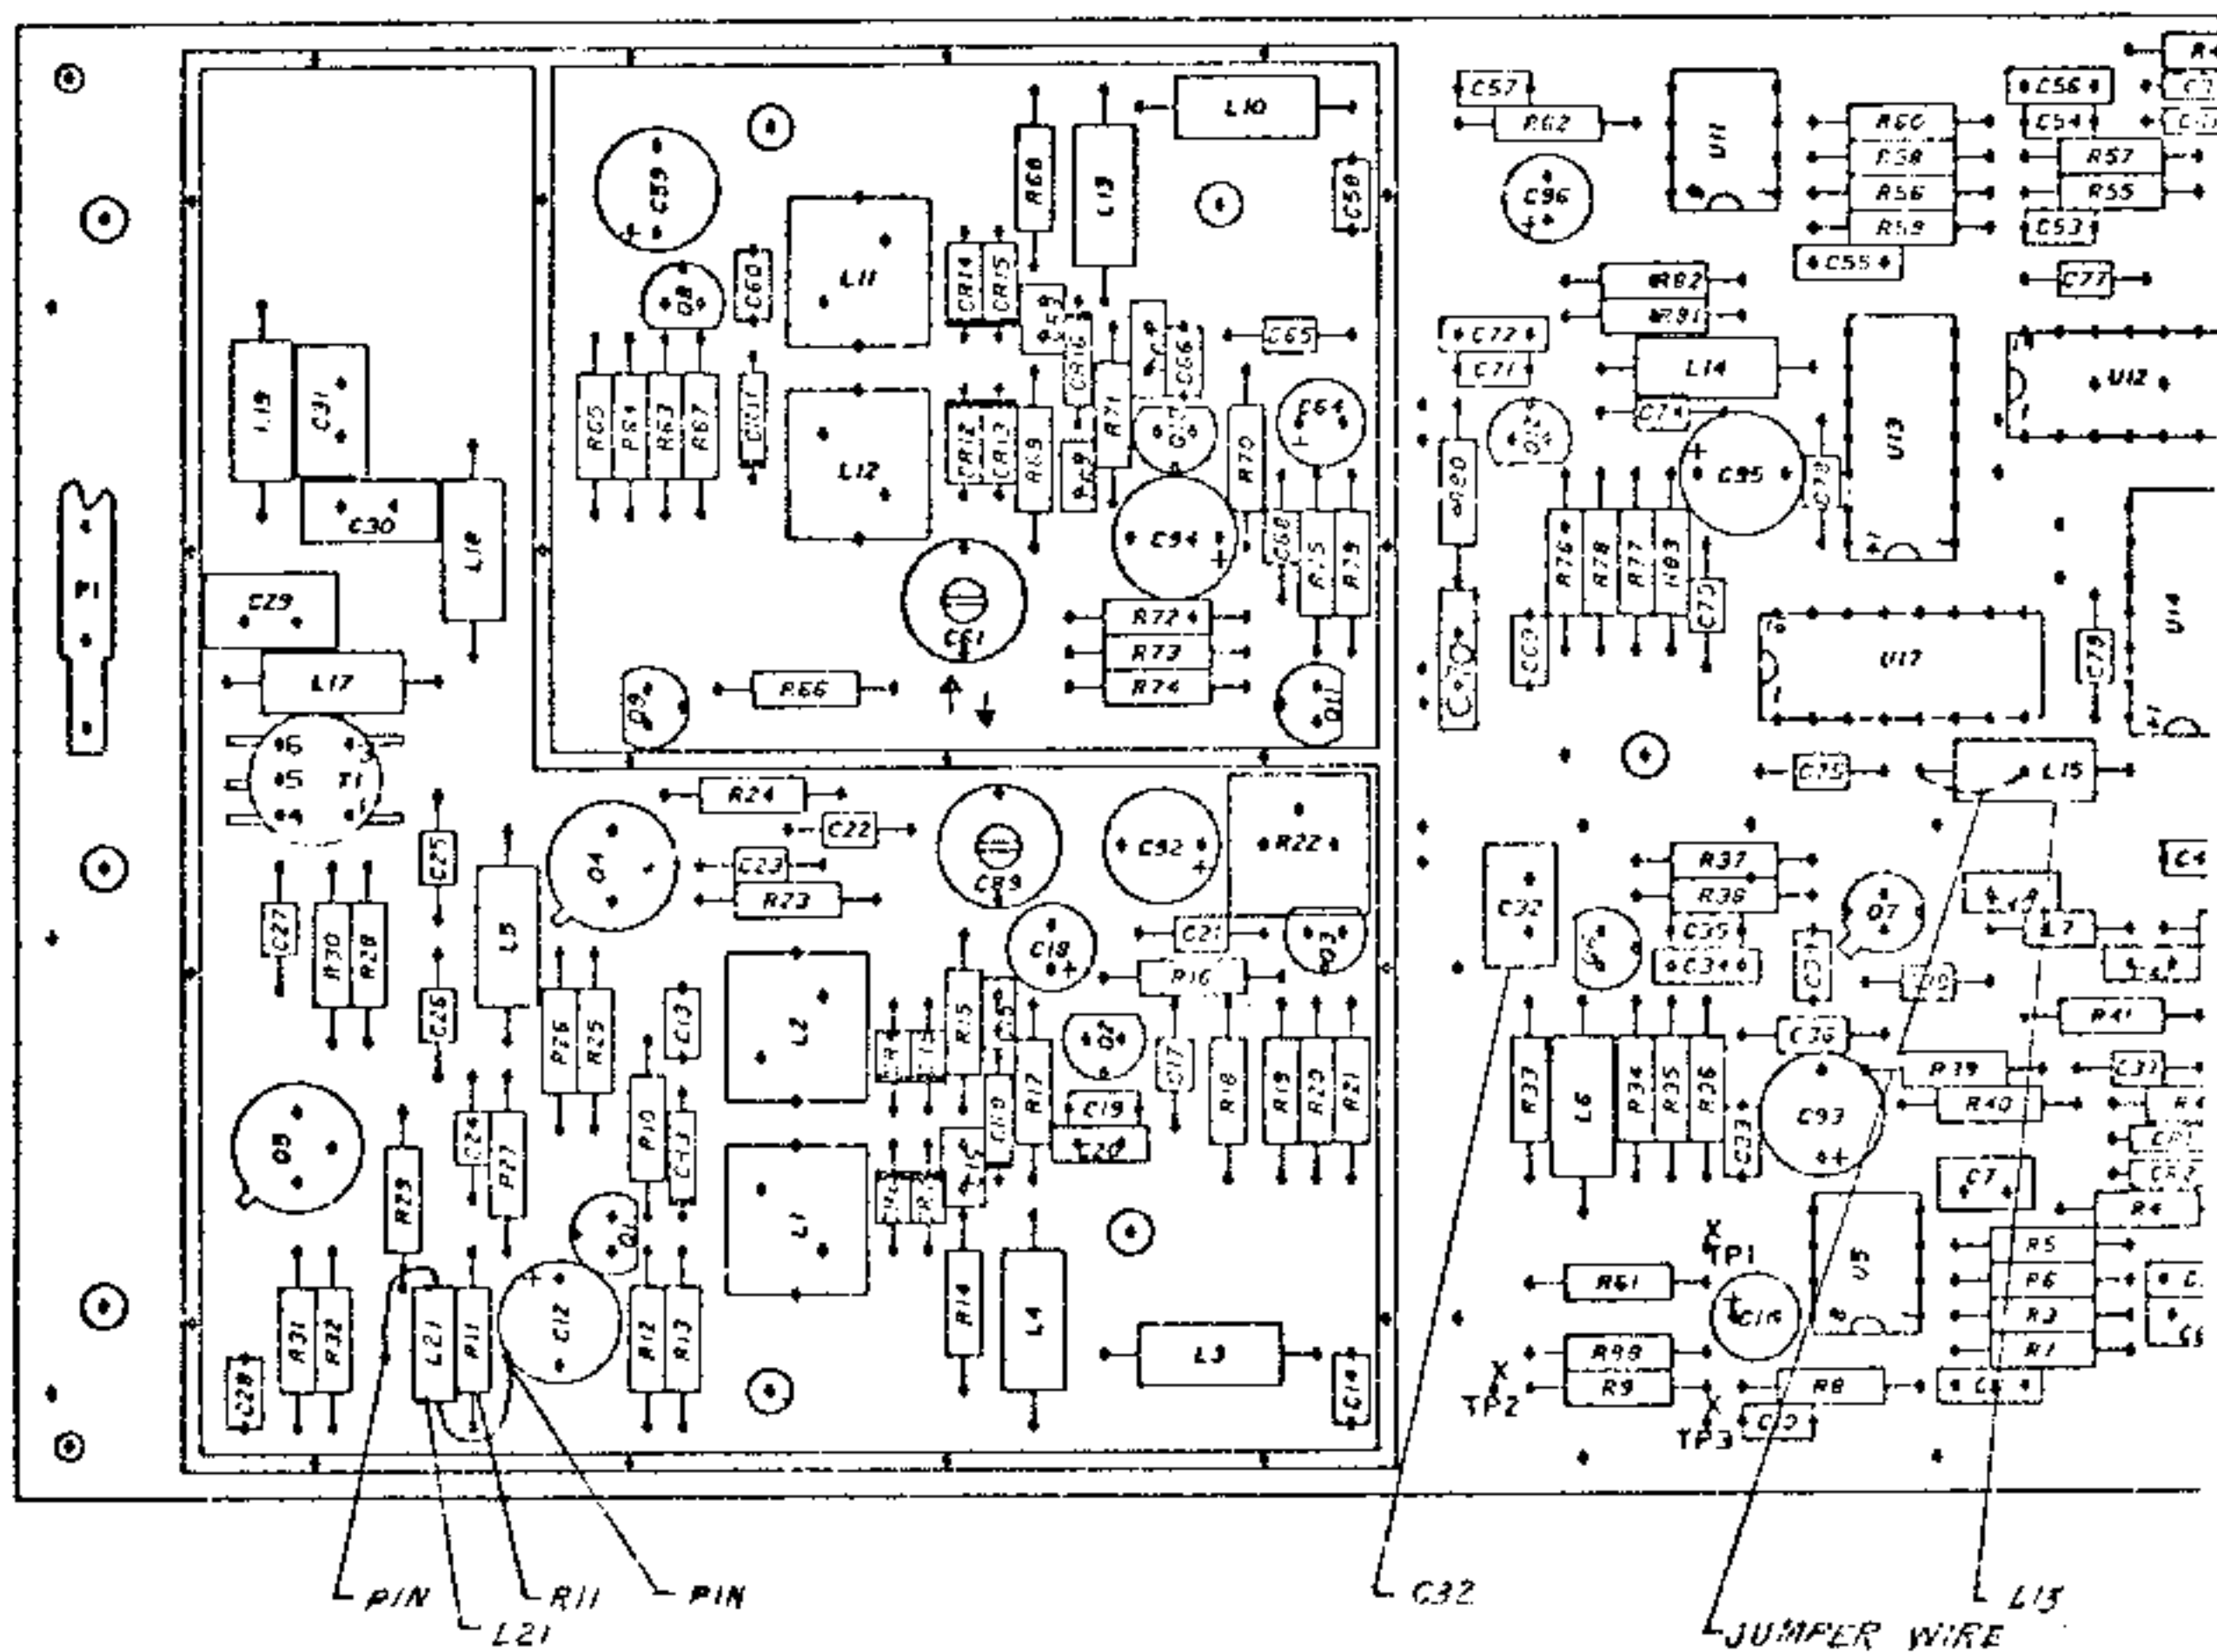
P/O Synthesizer Card A5A1 (638-6916-002)  
Figure 2

The purpose of this modification is to improve transmitter spectral purity when operating on a frequency ending in 257 kHz (ie 14, 257 kHz). This ensures that transmitter spurious output will be within the -50 dB specification limit.

This modification consists of making two circuit trace cuts, adding two pins and one coil, adding a jumper wire, and replacing one capacitor.

- J. Remove the 27-pF capacitor C32 and replace it with an 18-pF capacitor (913-1098-030).
  - K. On the bottom of the card, install a jumper wire (428-0282-050) from the left lead of L15 to the thru hole located under L15.

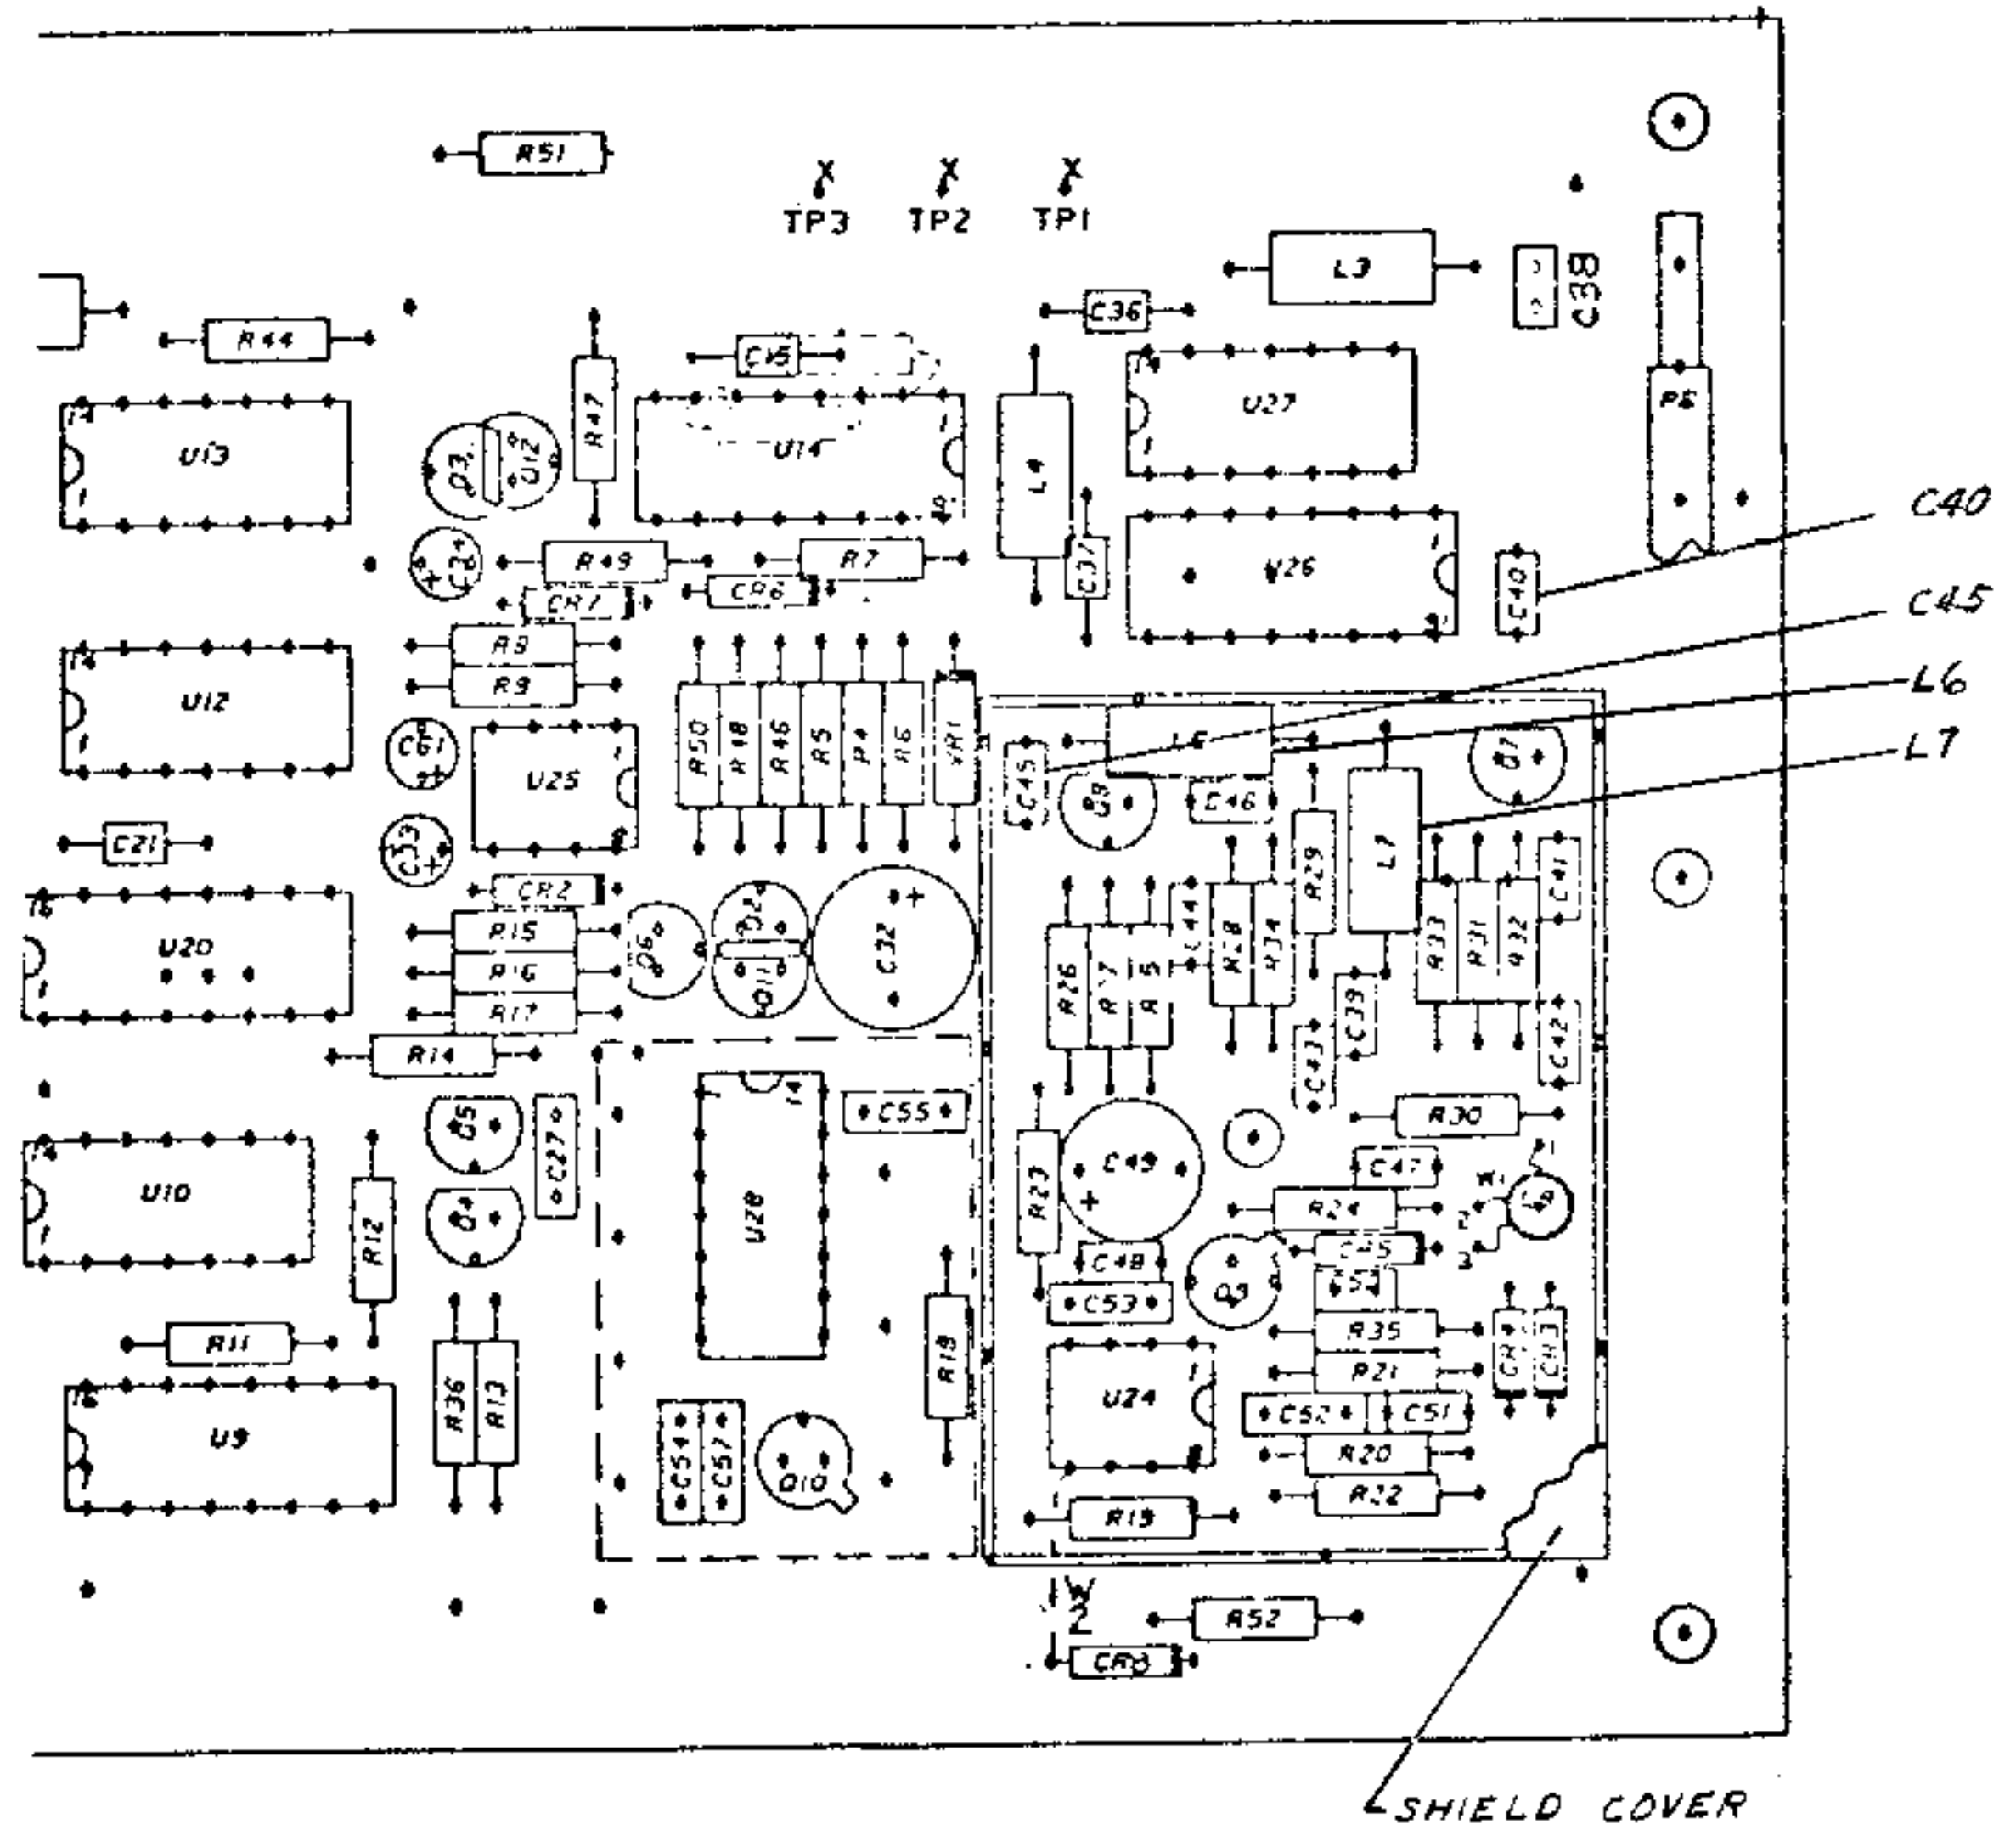
P/O Synthesizer Variable Reference Frequency Loop A5A2  
Figure 1

A frequency warble may occur at certain frequencies in some radios. The warble will usually occur at the top end of each 1 MHz band. The problem has been traced to two integrated circuits on synthesizer variable reference frequency loop A5A2. When U14 and U26 are at the low end of their specified parameters, a low rf input may cause them to miscount.

- F. Remove shield cover by removing seven screws.
  - G. Remove coils L6 and L7 and replace them with new 0.15  $\mu$ H coils (240-1562-000).
  - H. Remove capacitors C40 and C45 and replace them with new 4 pF capacitors (912-4141-080).

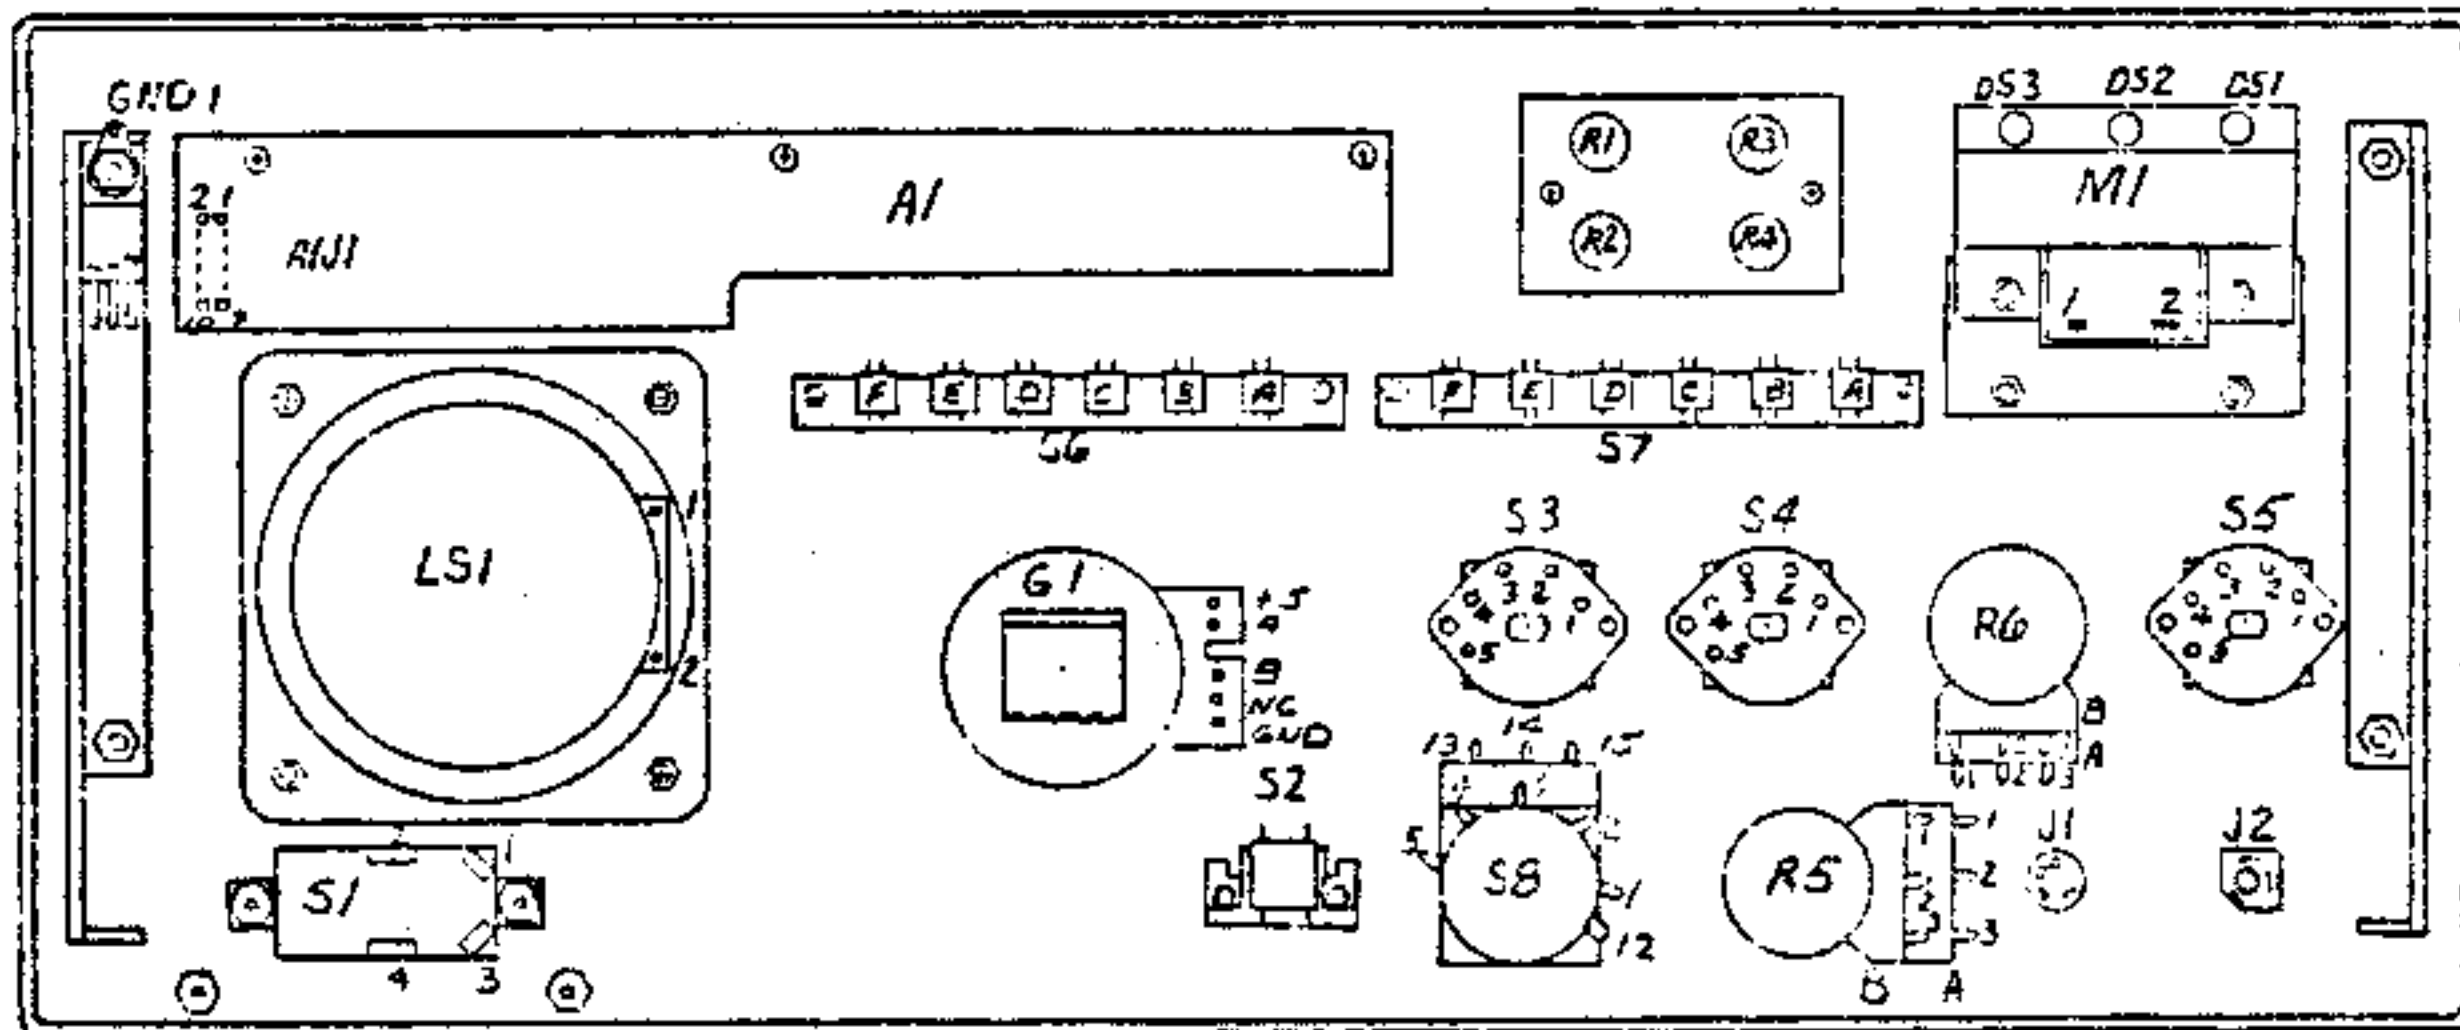
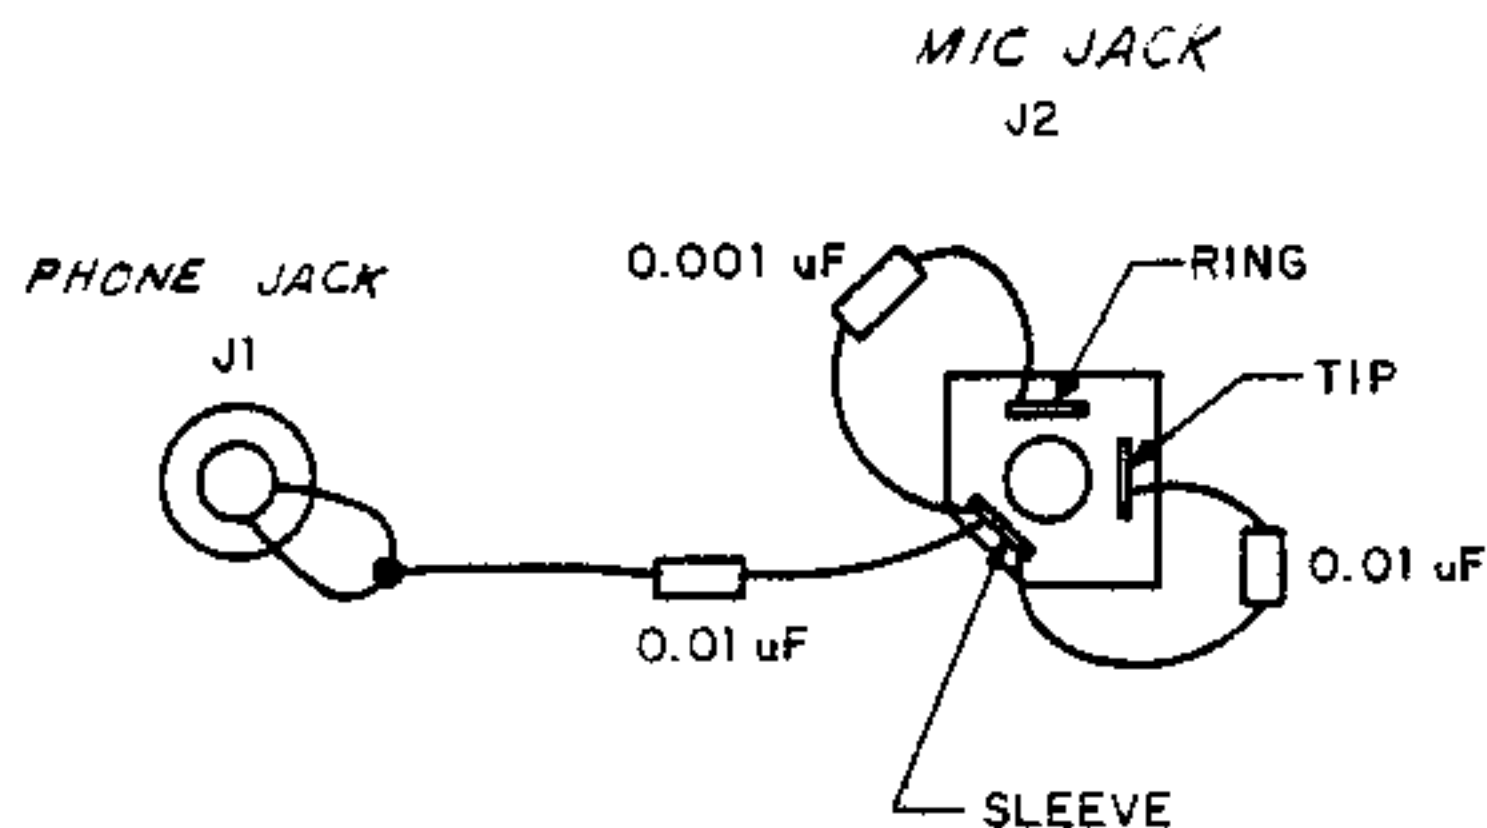
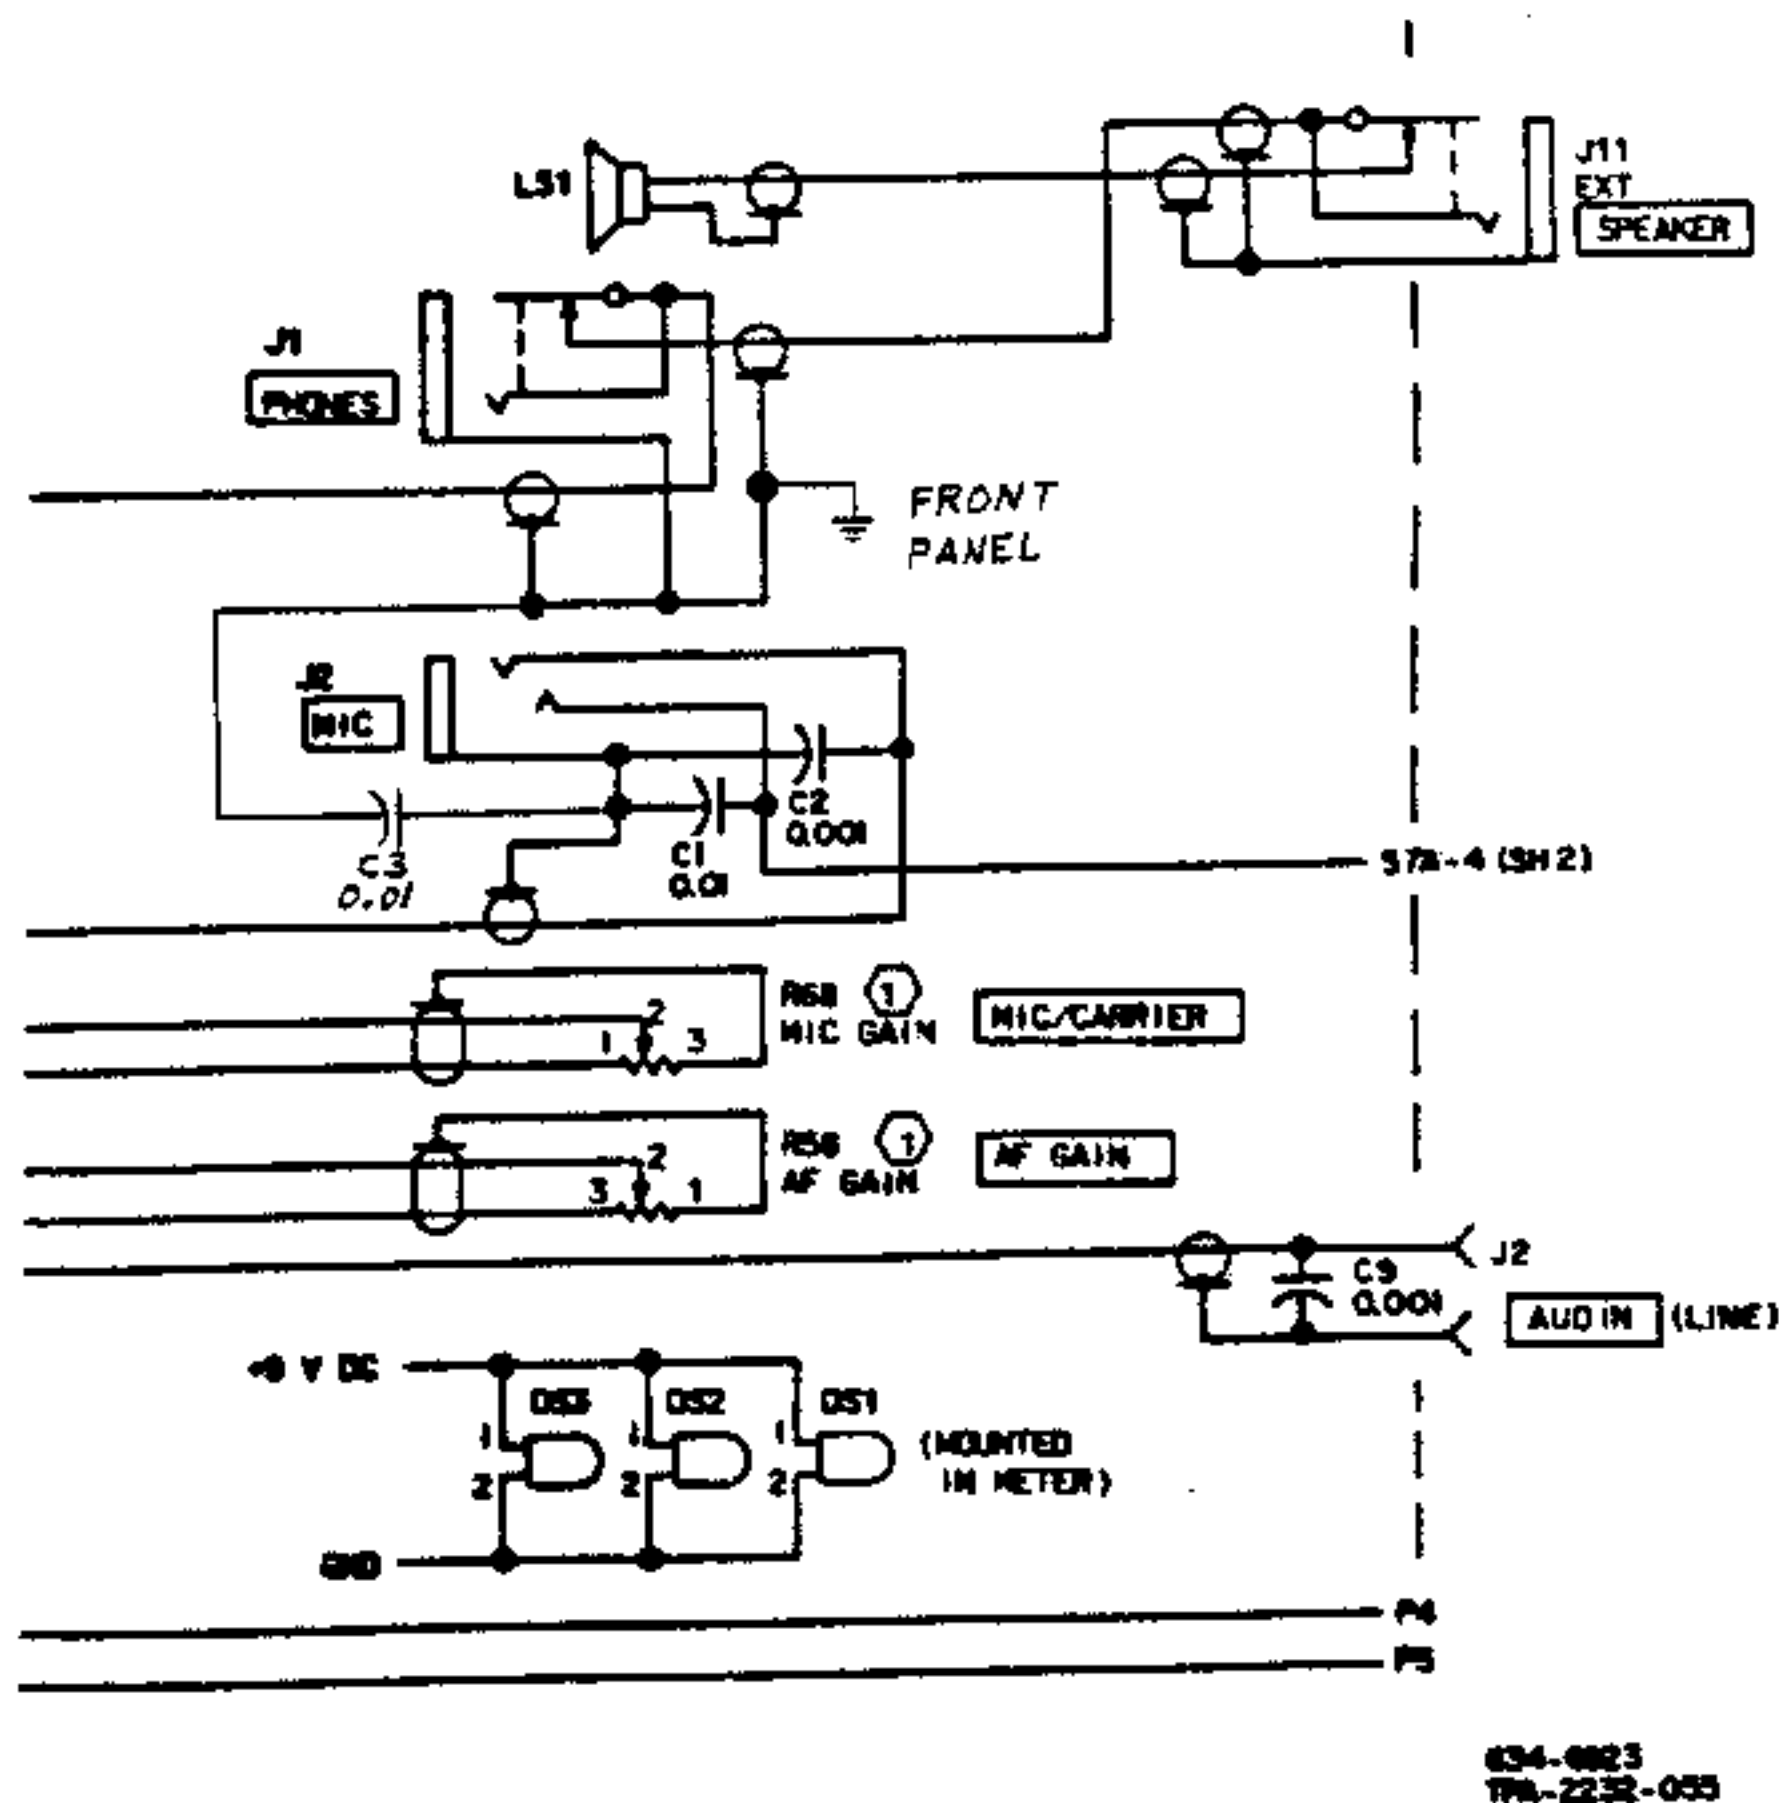
KWM-380/HF-380 Front Panel, Rear View  
Figure 1

The purpose of this service bulletin is to correct a transmit hum caused by a ground loop between the front panel and the receiver/exciter card ground plane.

This modification replaces the mic jack (J2) with a jack that has an insulated sleeve contact to break the ground loop.

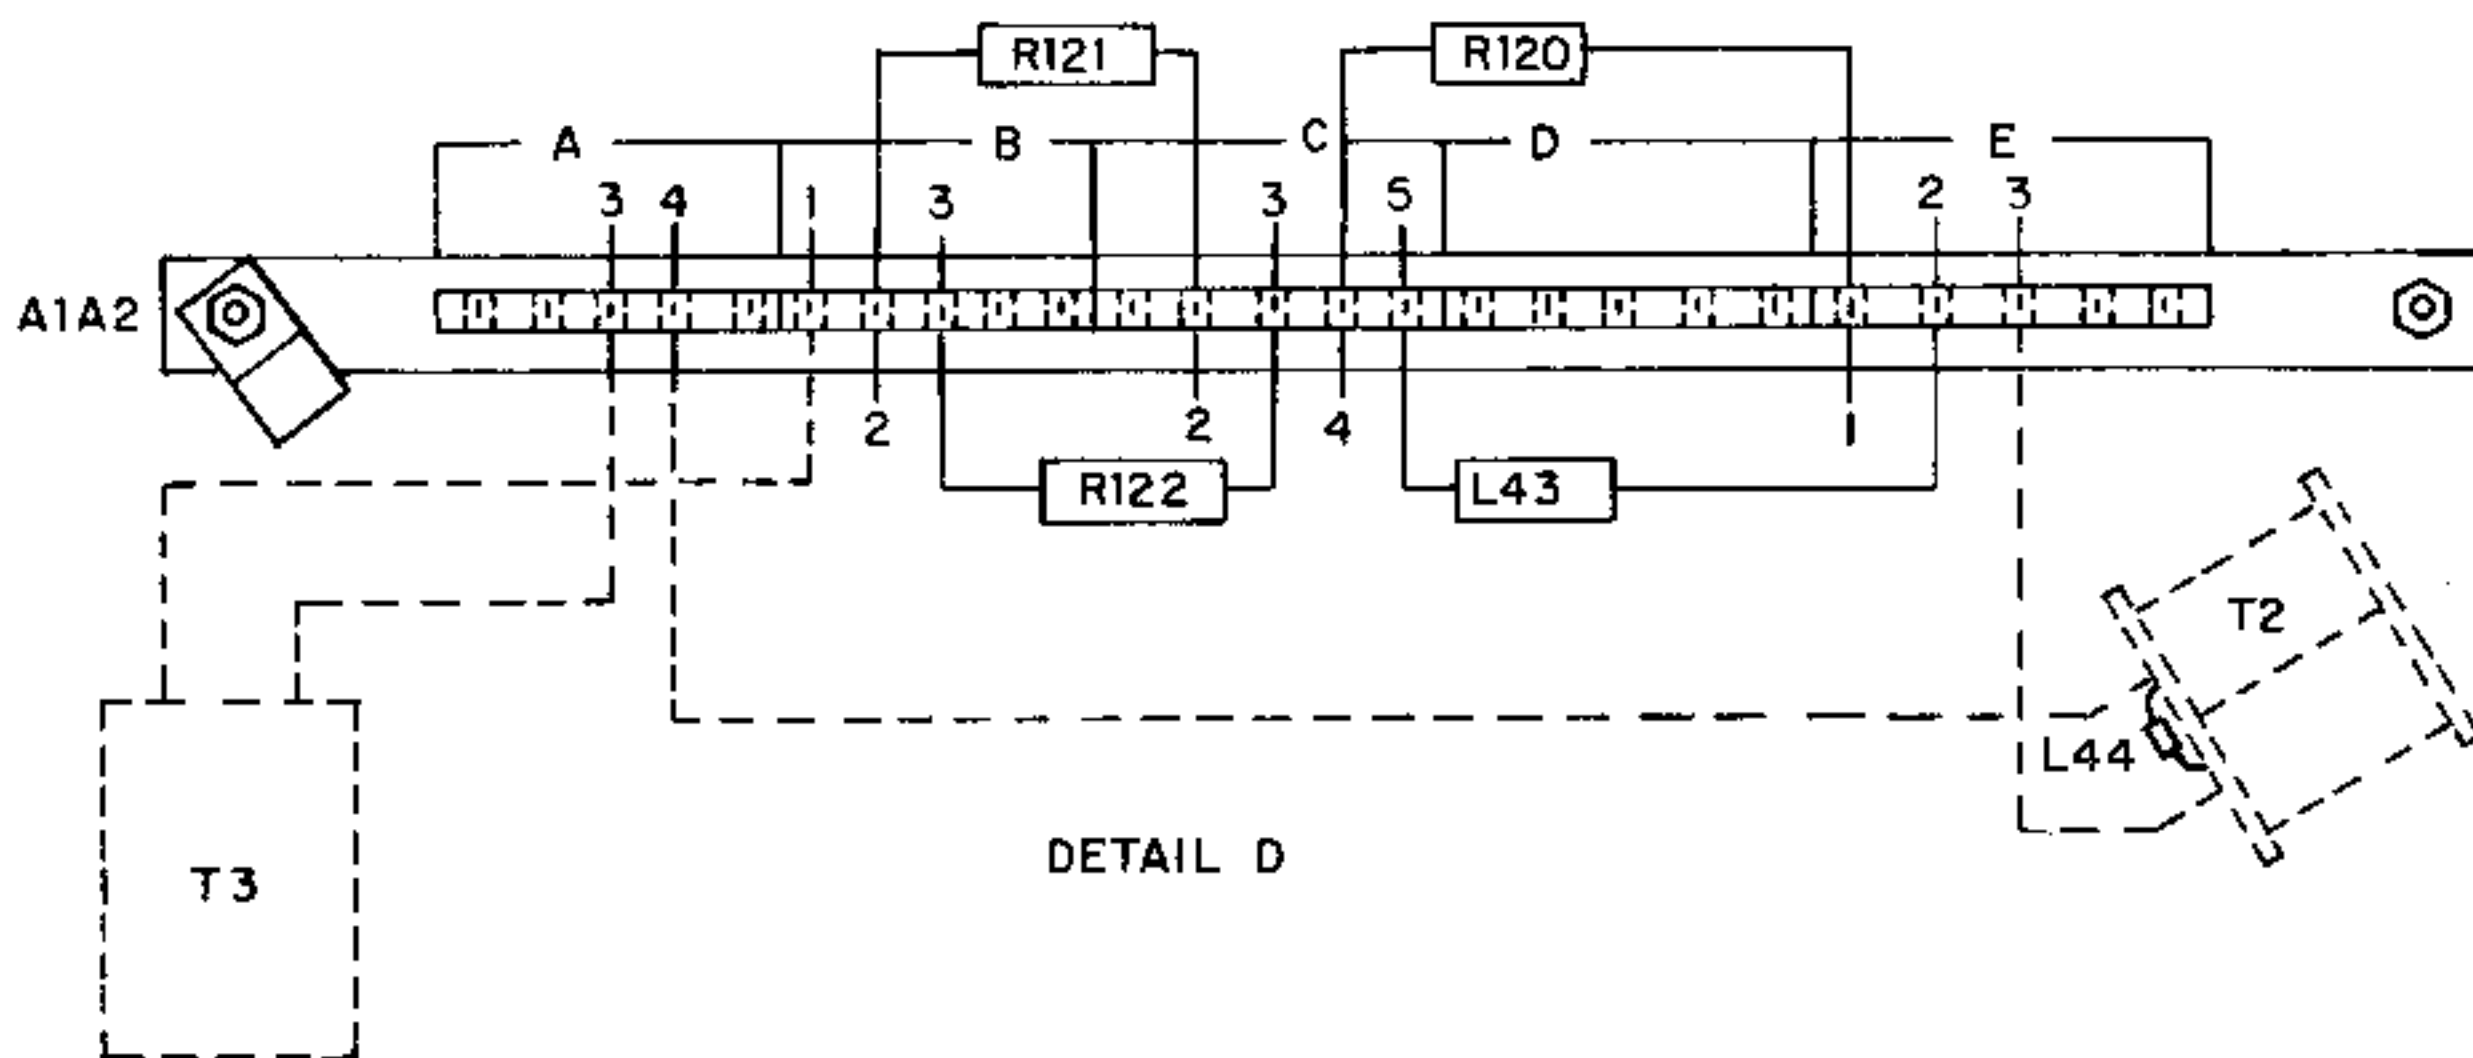
NOTE: LEADS FROM T2 AND T3 MUST BE CAREFULLY POSITIONED AS SHOWN TO PREVENT DESTRUCTIVE OSCILLATION.

- K. Install 100- $\Omega$  resistor R124 (745-1310-000) in parallel with L24. Wrap the resistor leads around the coil leads and solder.
- L. Examine transistors Q41A/B and resistor R7. If Q41 was manufactured by Motorola, the value of R7 should be 15  $\Omega$ . If Q41 was manufactured by CTC, the value of R7 should be 27  $\Omega$ . If it is necessary to replace R7, cut the resistor leads close to component body, leaving the leads soldered into the circuit card. Install the new resistor (15  $\Omega$ , 745-0683-000, or 27  $\Omega$ , 745-0692-000), attaching the leads to the old resistor leads.
