KWM-380 TRANSCEIVER (622-5093-101)  
HF-380 TRANSCEIVER (622-3580-101)  
RECEIVER-EXCITER CIRCUIT CARD A3 (638-6908-001)

**SERVICE BULLETIN NO 1****PRODUCT IMPROVEMENT**

KWM-380 TRANSCEIVER (622-5093-001, -101)  
HF-380 TRANSCEIVER (622-3580-001, -101)  
SYNTHESIZER A5A1 (638-6916-001, -002)

## SERVICE BULLETIN NO 2

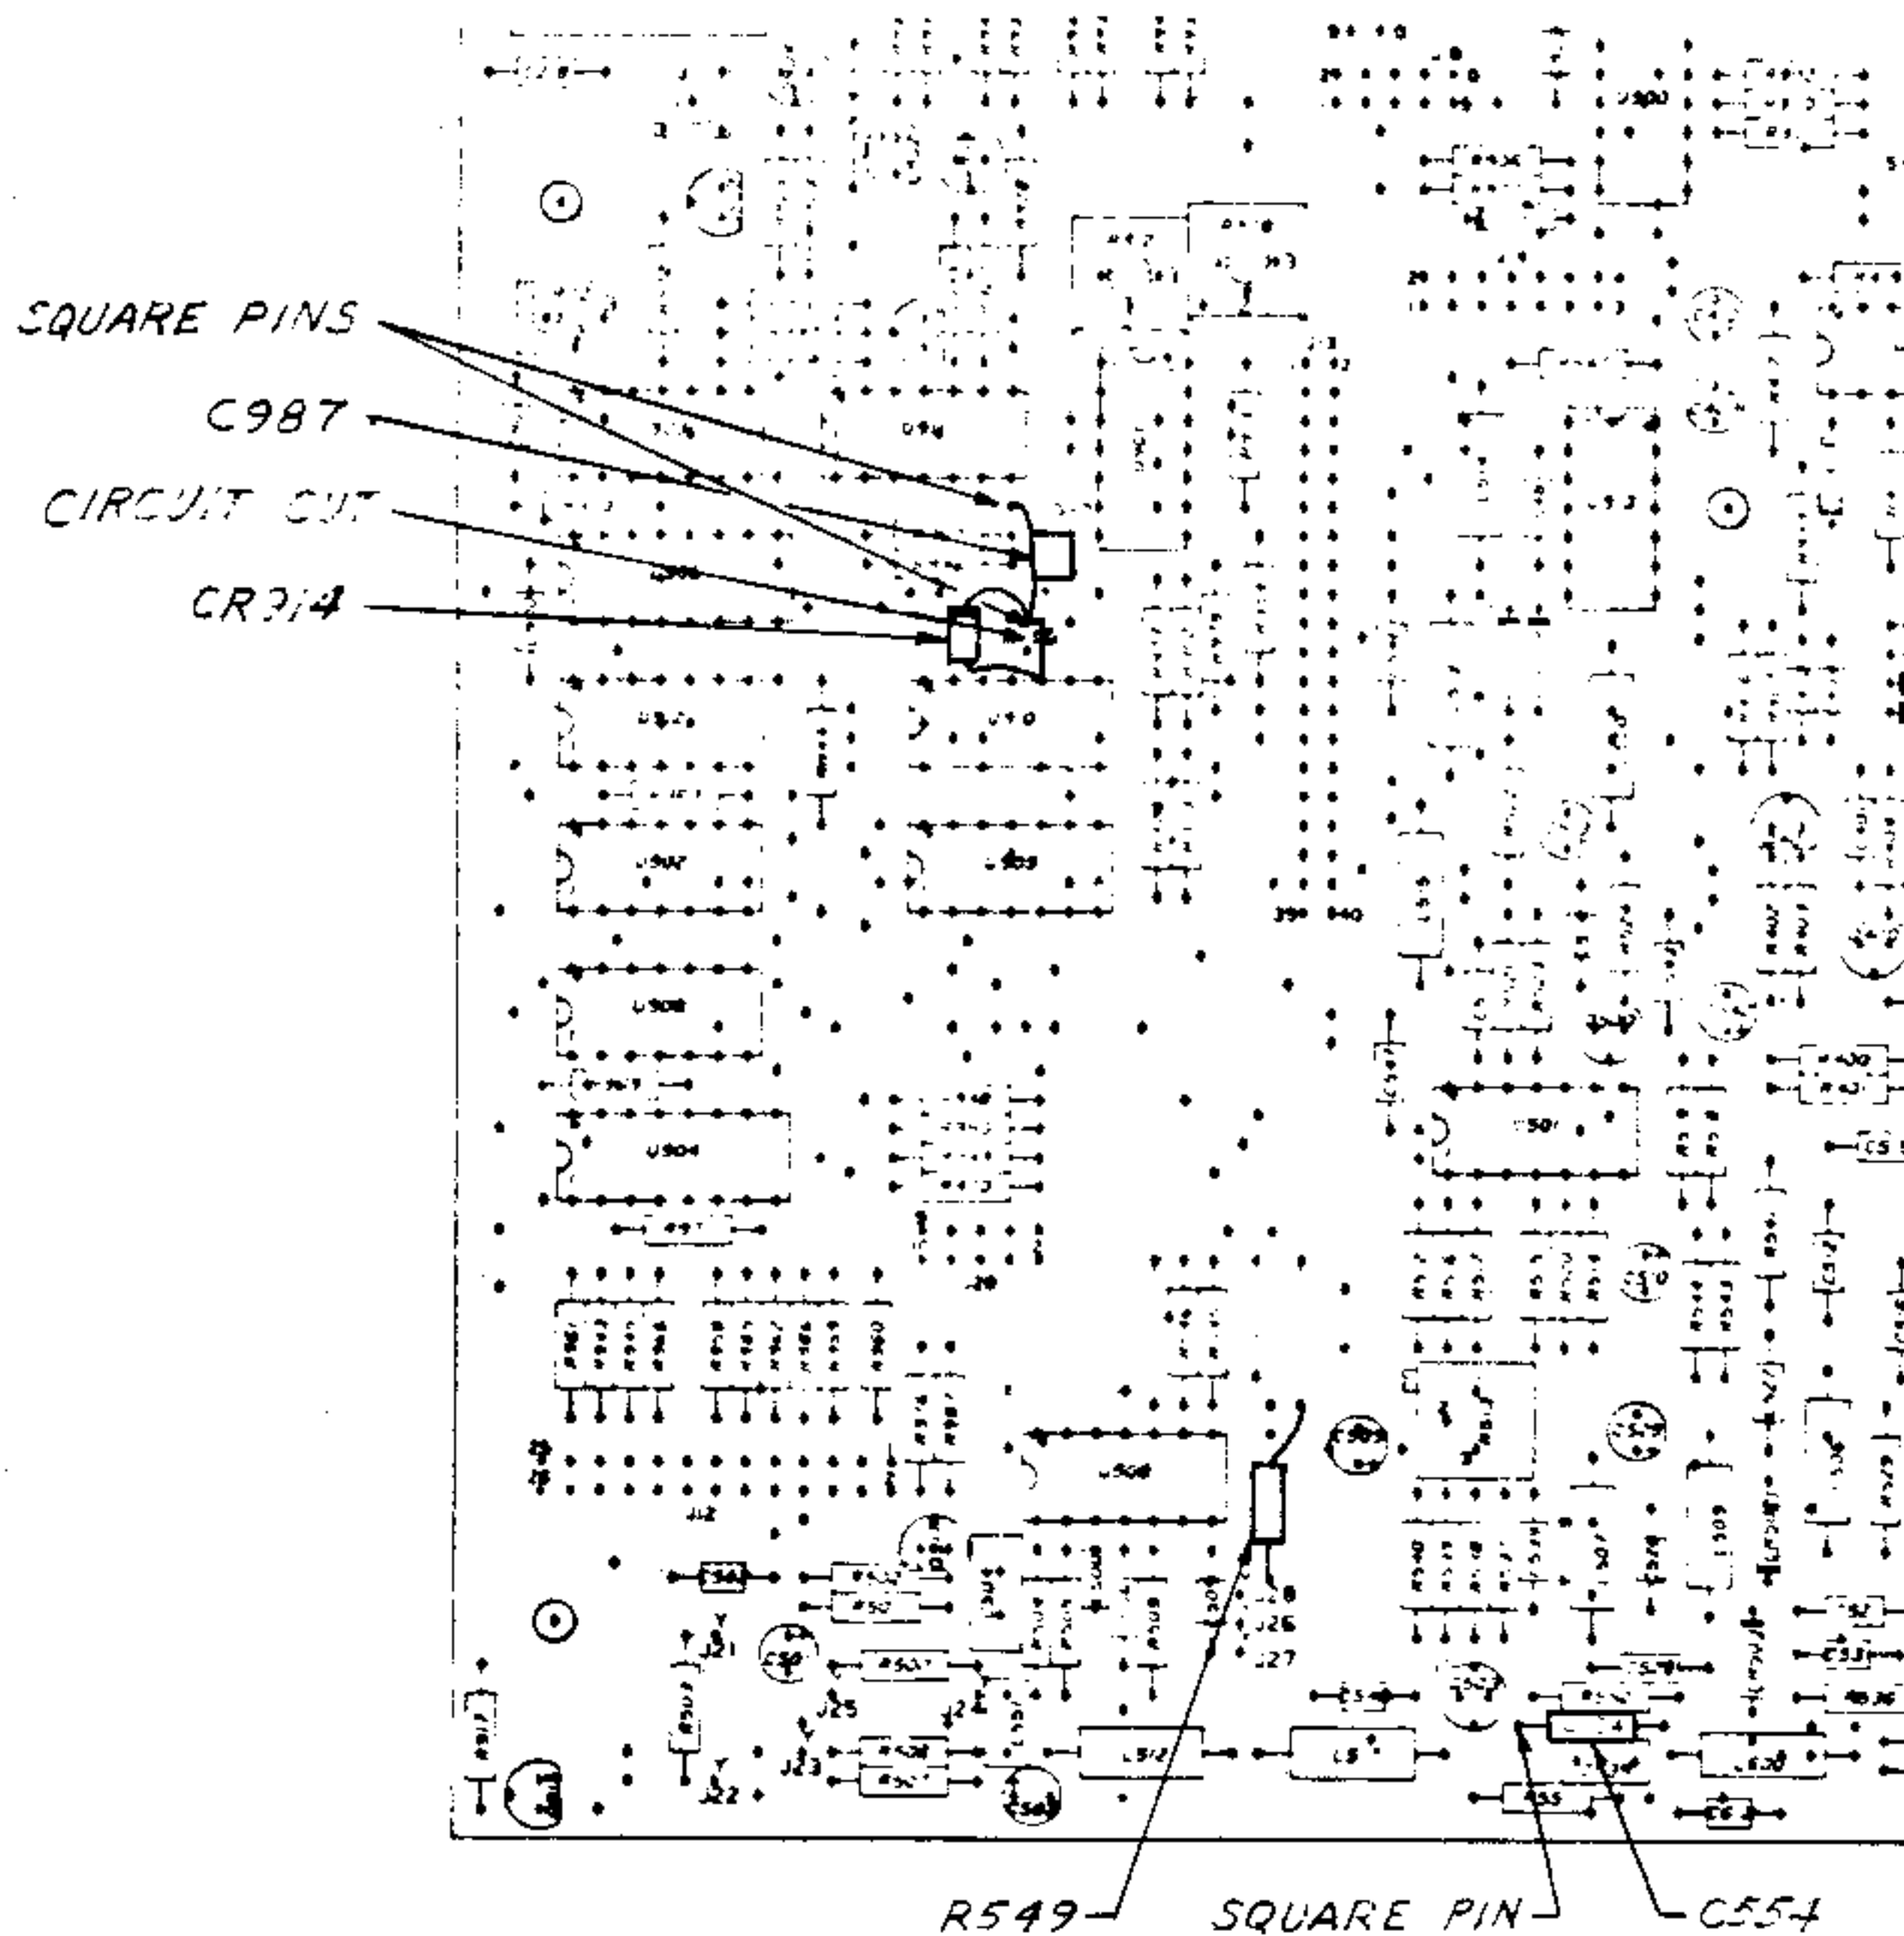
P/O Receiver-Exciter Card A3  
Figure 1

The rise and decay time of the cw envelope is less than 1 ms which may cause key clicks to be evident. This modification increases the rise and decay times to a nominal 4 ms. This still produces a hard, but click-free, waveform. This timing may be altered if desired by changing the value of R549. Increase the value to soften the keying, decrease the value to harden the keying.

**NOTE:** All changes are made to receiver-exciter assembly A3, located on the bottom of the unit. Taking care to not damage adjacent components, these modifications can be made without removing A3 from the chassis. Refer to Receiver-Exciter A3 instructions in the circuit cards section located in the back of the HF-380 and KWM-380 service manuals for location of components to be removed. Refer to figure 1 of this bulletin for location of added components. Refer to figure 2 for a schematic diagram which includes the changes made by this modification.

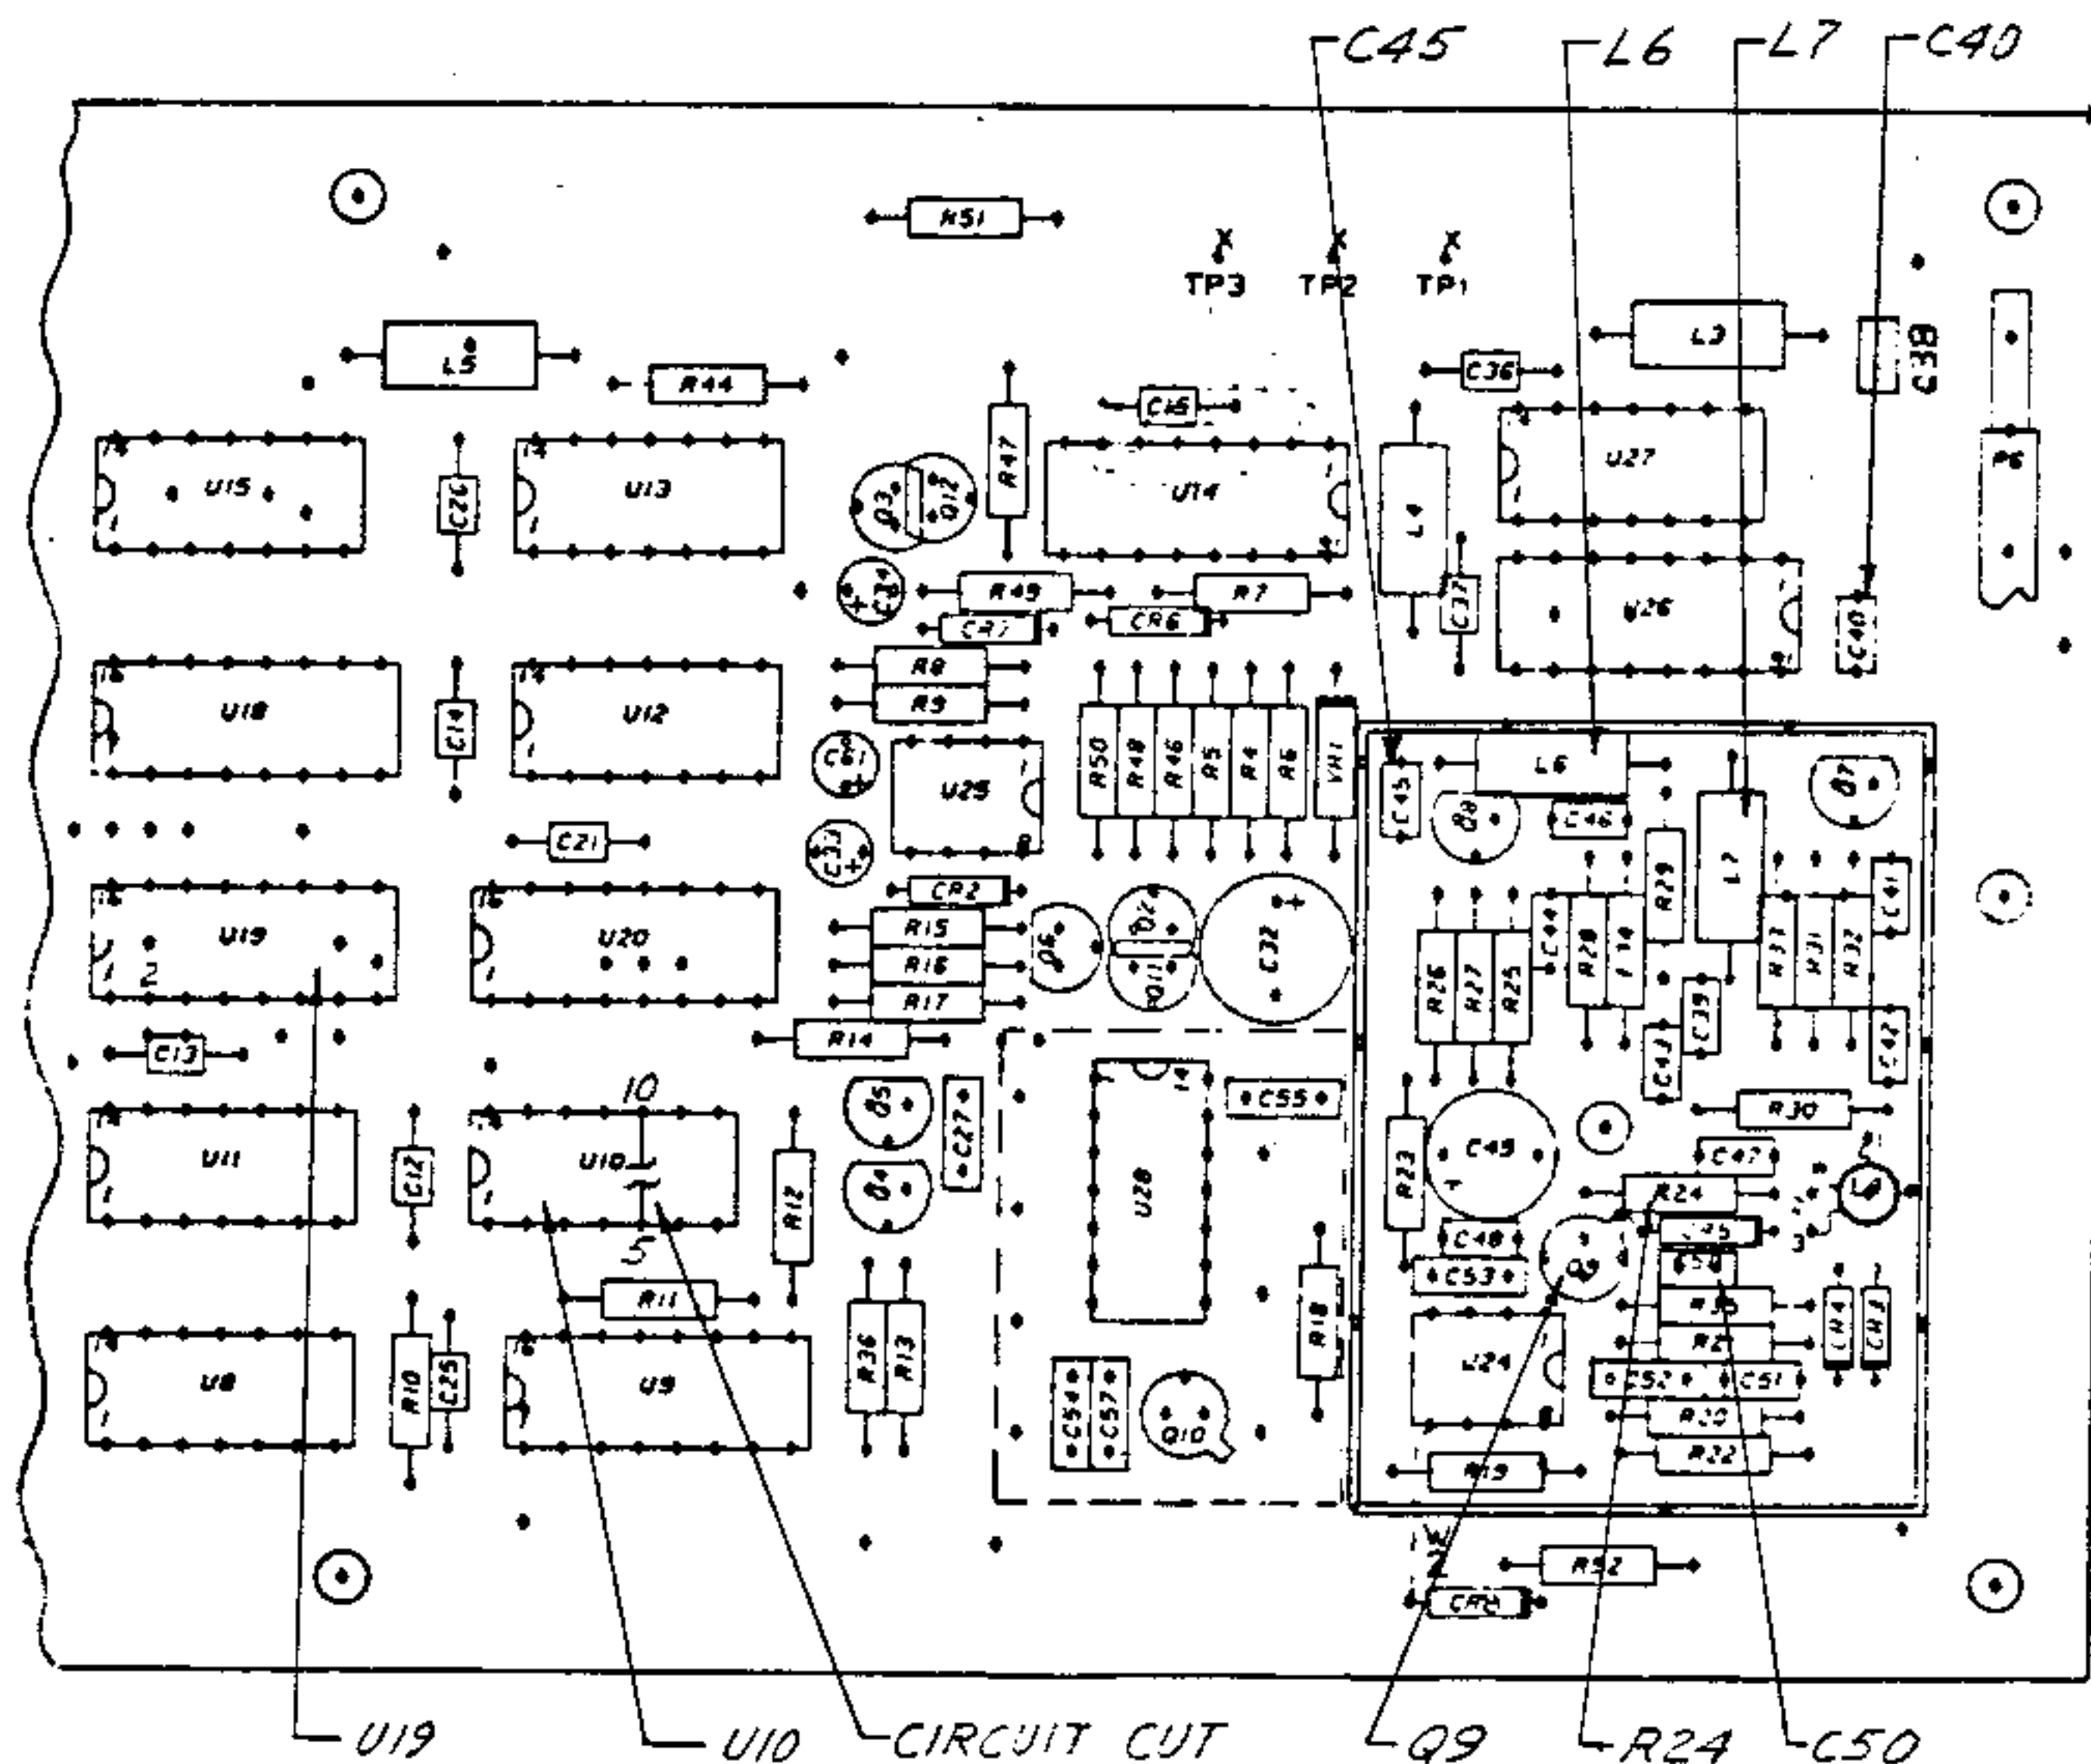
P/O Synthesizer Variable Reference Frequency Loop A5A2

A frequency warble may occur at certain frequencies in some radios. The warble will usually occur at the top end of each 1-MHz band. The problem has been traced to two integrated circuits on synthesizer variable frequency loop A5A2. When U14 and U26 are at the low end of their specified parameters, a low rf input may cause them to miscount. Steps F through L of the modification procedure will correct this problem.

The synthesizer 500-Hz sidebands can be observed as a false signal 500 Hz away from a strong cw carrier when tuning with a narrow cw crystal filter. This service bulletin (steps M and N of the modification procedure) reduces the 500-Hz sideband level on the synthesizer output (first receiver mixer local oscillator).

- F. Remove 4-pF capacitor C40 and replace it with a 12-pF capacitor (912-4141-120).
- G. Remove 4-pF capacitor C45 and replace it with a 12-pF capacitor (912-4141-120).
- H. Remove transistor Q9 (2N5486) and replace it with a 2N5397 transistor (352-0998-010).
- I. Remove 0.15- $\mu$ H coil L6 and replace it with a 0.10- $\mu$ H coil (240-2723-140).
- J. Remove 0.15- $\mu$ H coil L7 and replace it with a 0.10- $\mu$ H coil (240-2723-140).
- K. Remove 47-pF capacitor C50 and replace it with a 27-pF capacitor (913-1098-570).
- L. Remove 154- $\Omega$  resistor R24 and replace it with a 56- $\Omega$  resistor (745-0704-000).
- M. On the bottom of the card, cut the circuit trace which connects U10-5 to U10-10.
- N. Install a jumper wire (428-0282-050) from U19-2 to U10-5 on the bottom of the card.
- O. Mark SB 16 on the circuit card near the part number.
