KWM-380 TRANSCEIVER (622-5093-101)  
HF-380 TRANSCEIVER (622-3580-101)  
RECEIVER-EXCITER CIRCUIT CARD A3 (638-6908-001)

**SERVICE BULLETIN NO 1****PRODUCT IMPROVEMENT**

KWM-380 TRANSCEIVER (622-5093-001, -101)  
HF-380 TRANSCEIVER (622-3580-001, -101)  
SYNTHESIZER A5A1 (638-6916-001, -002)

## SERVICE BULLETIN NO 2

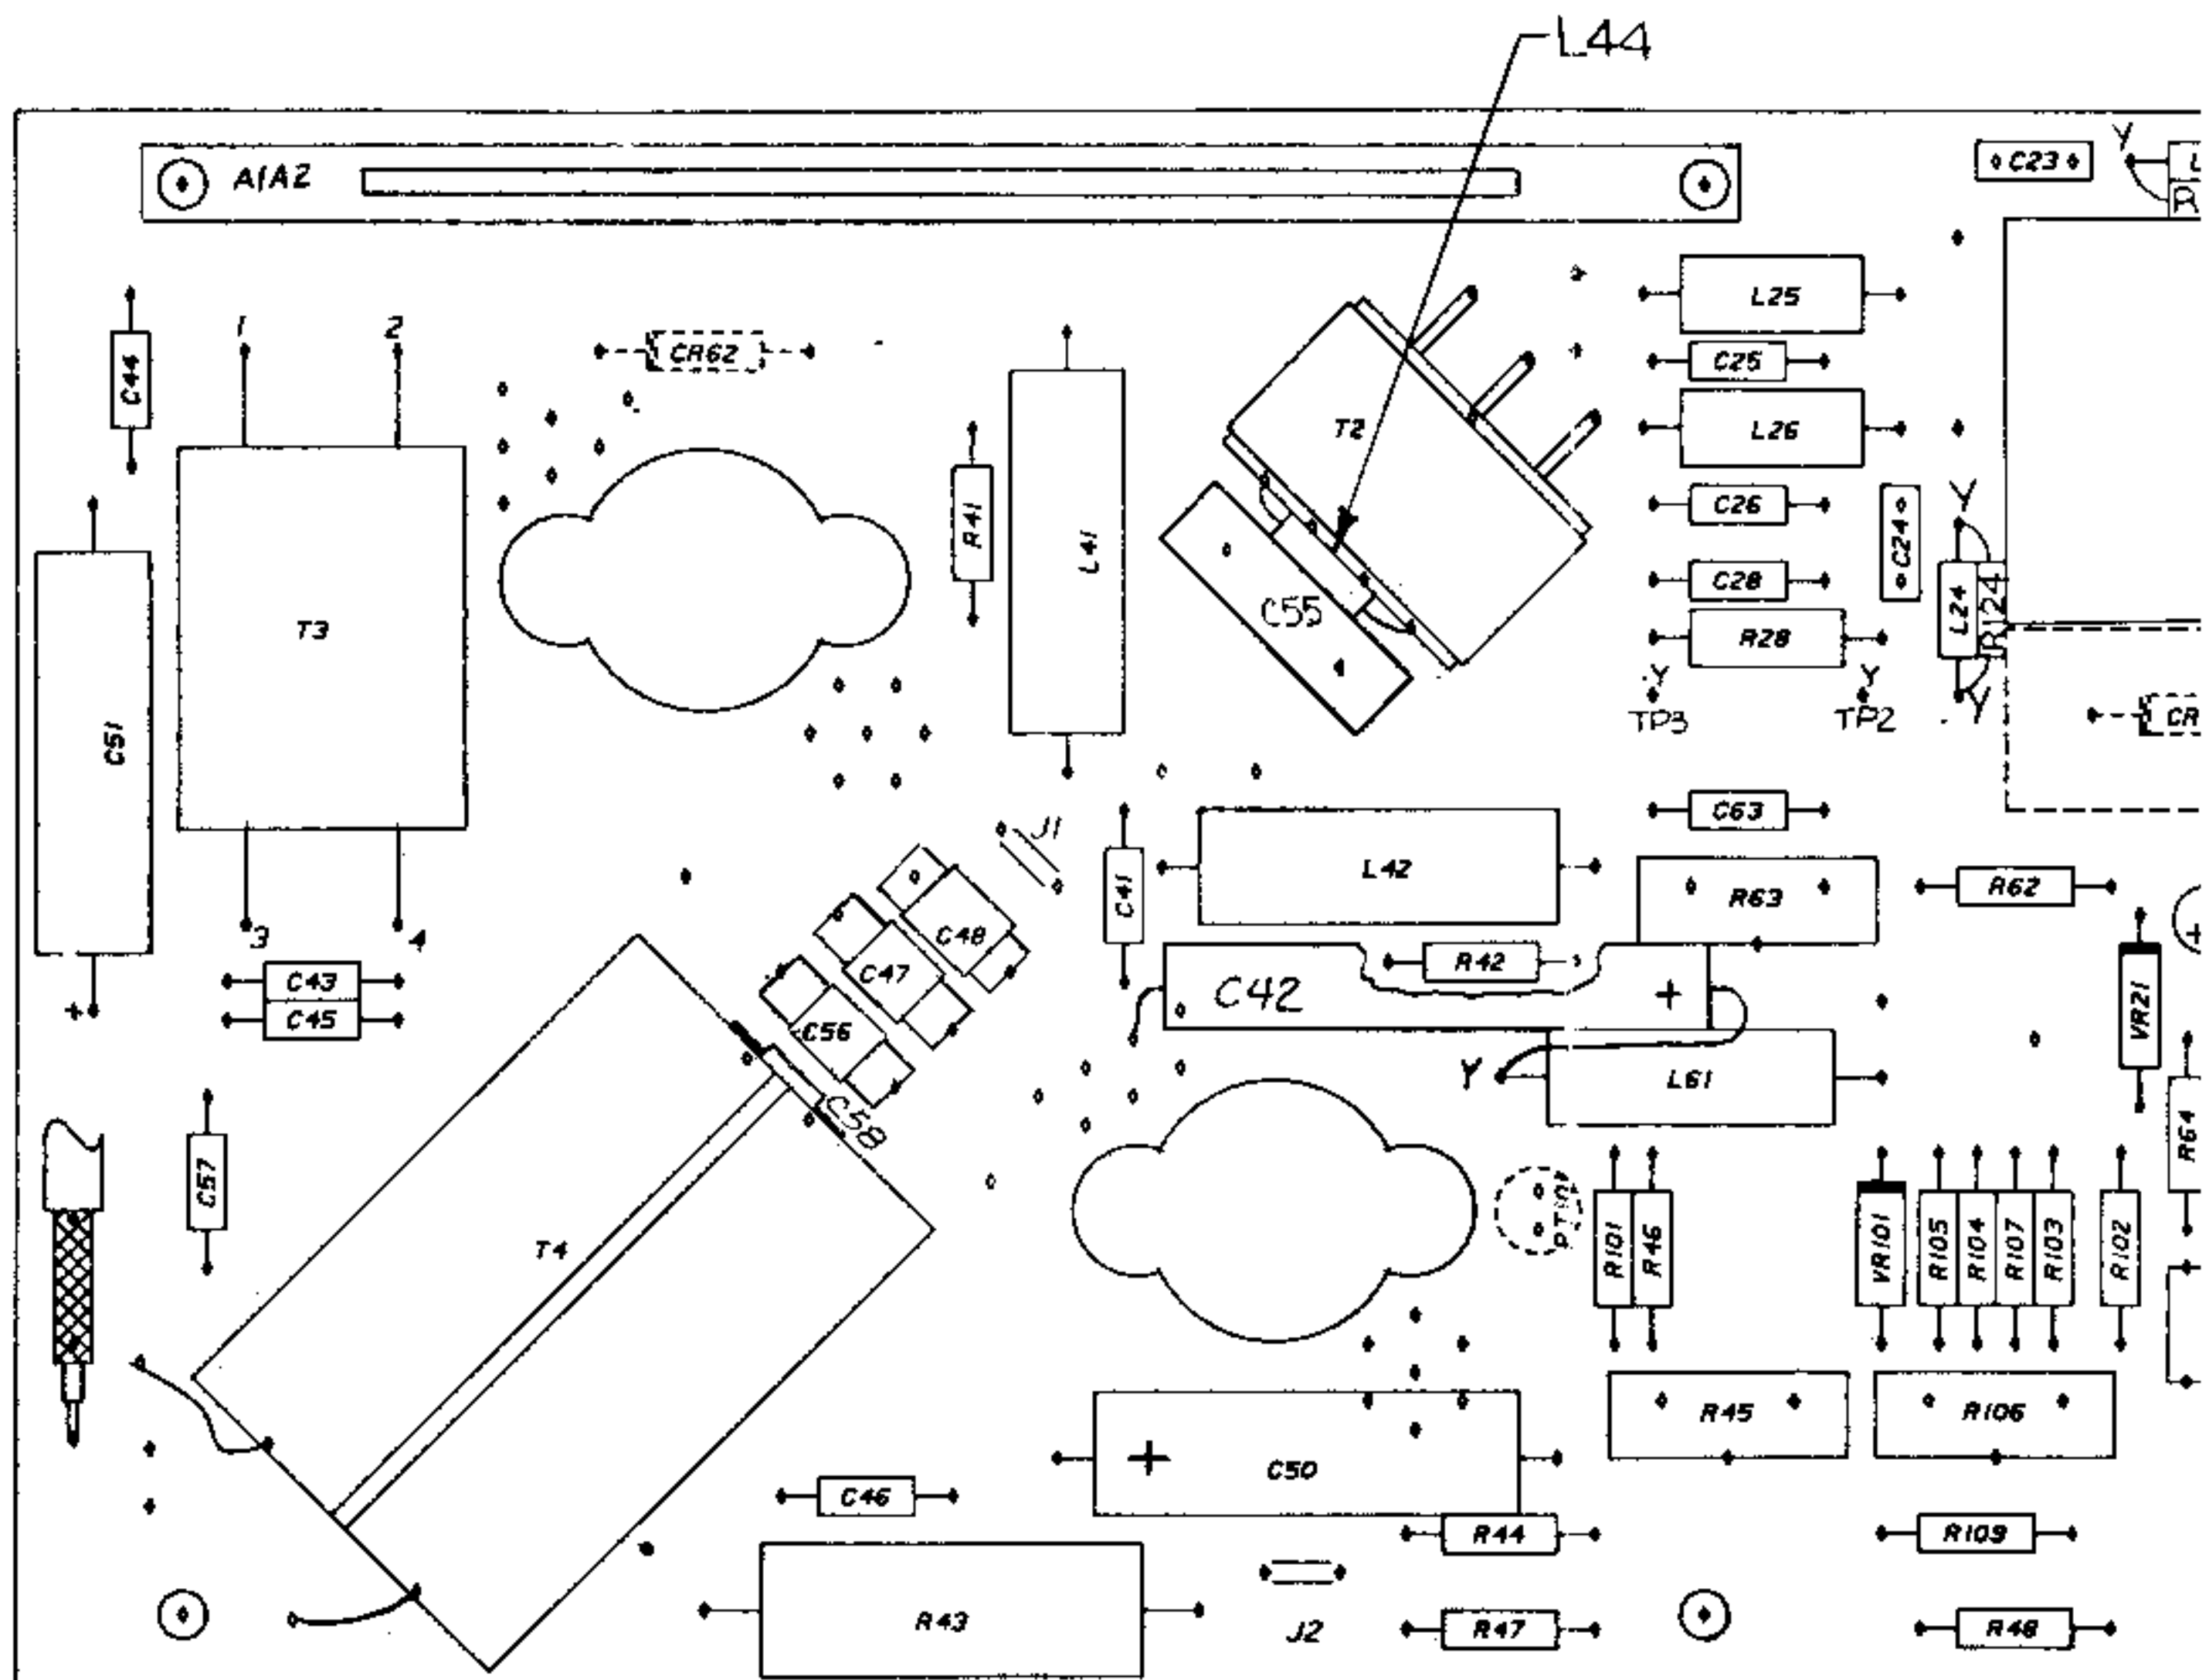
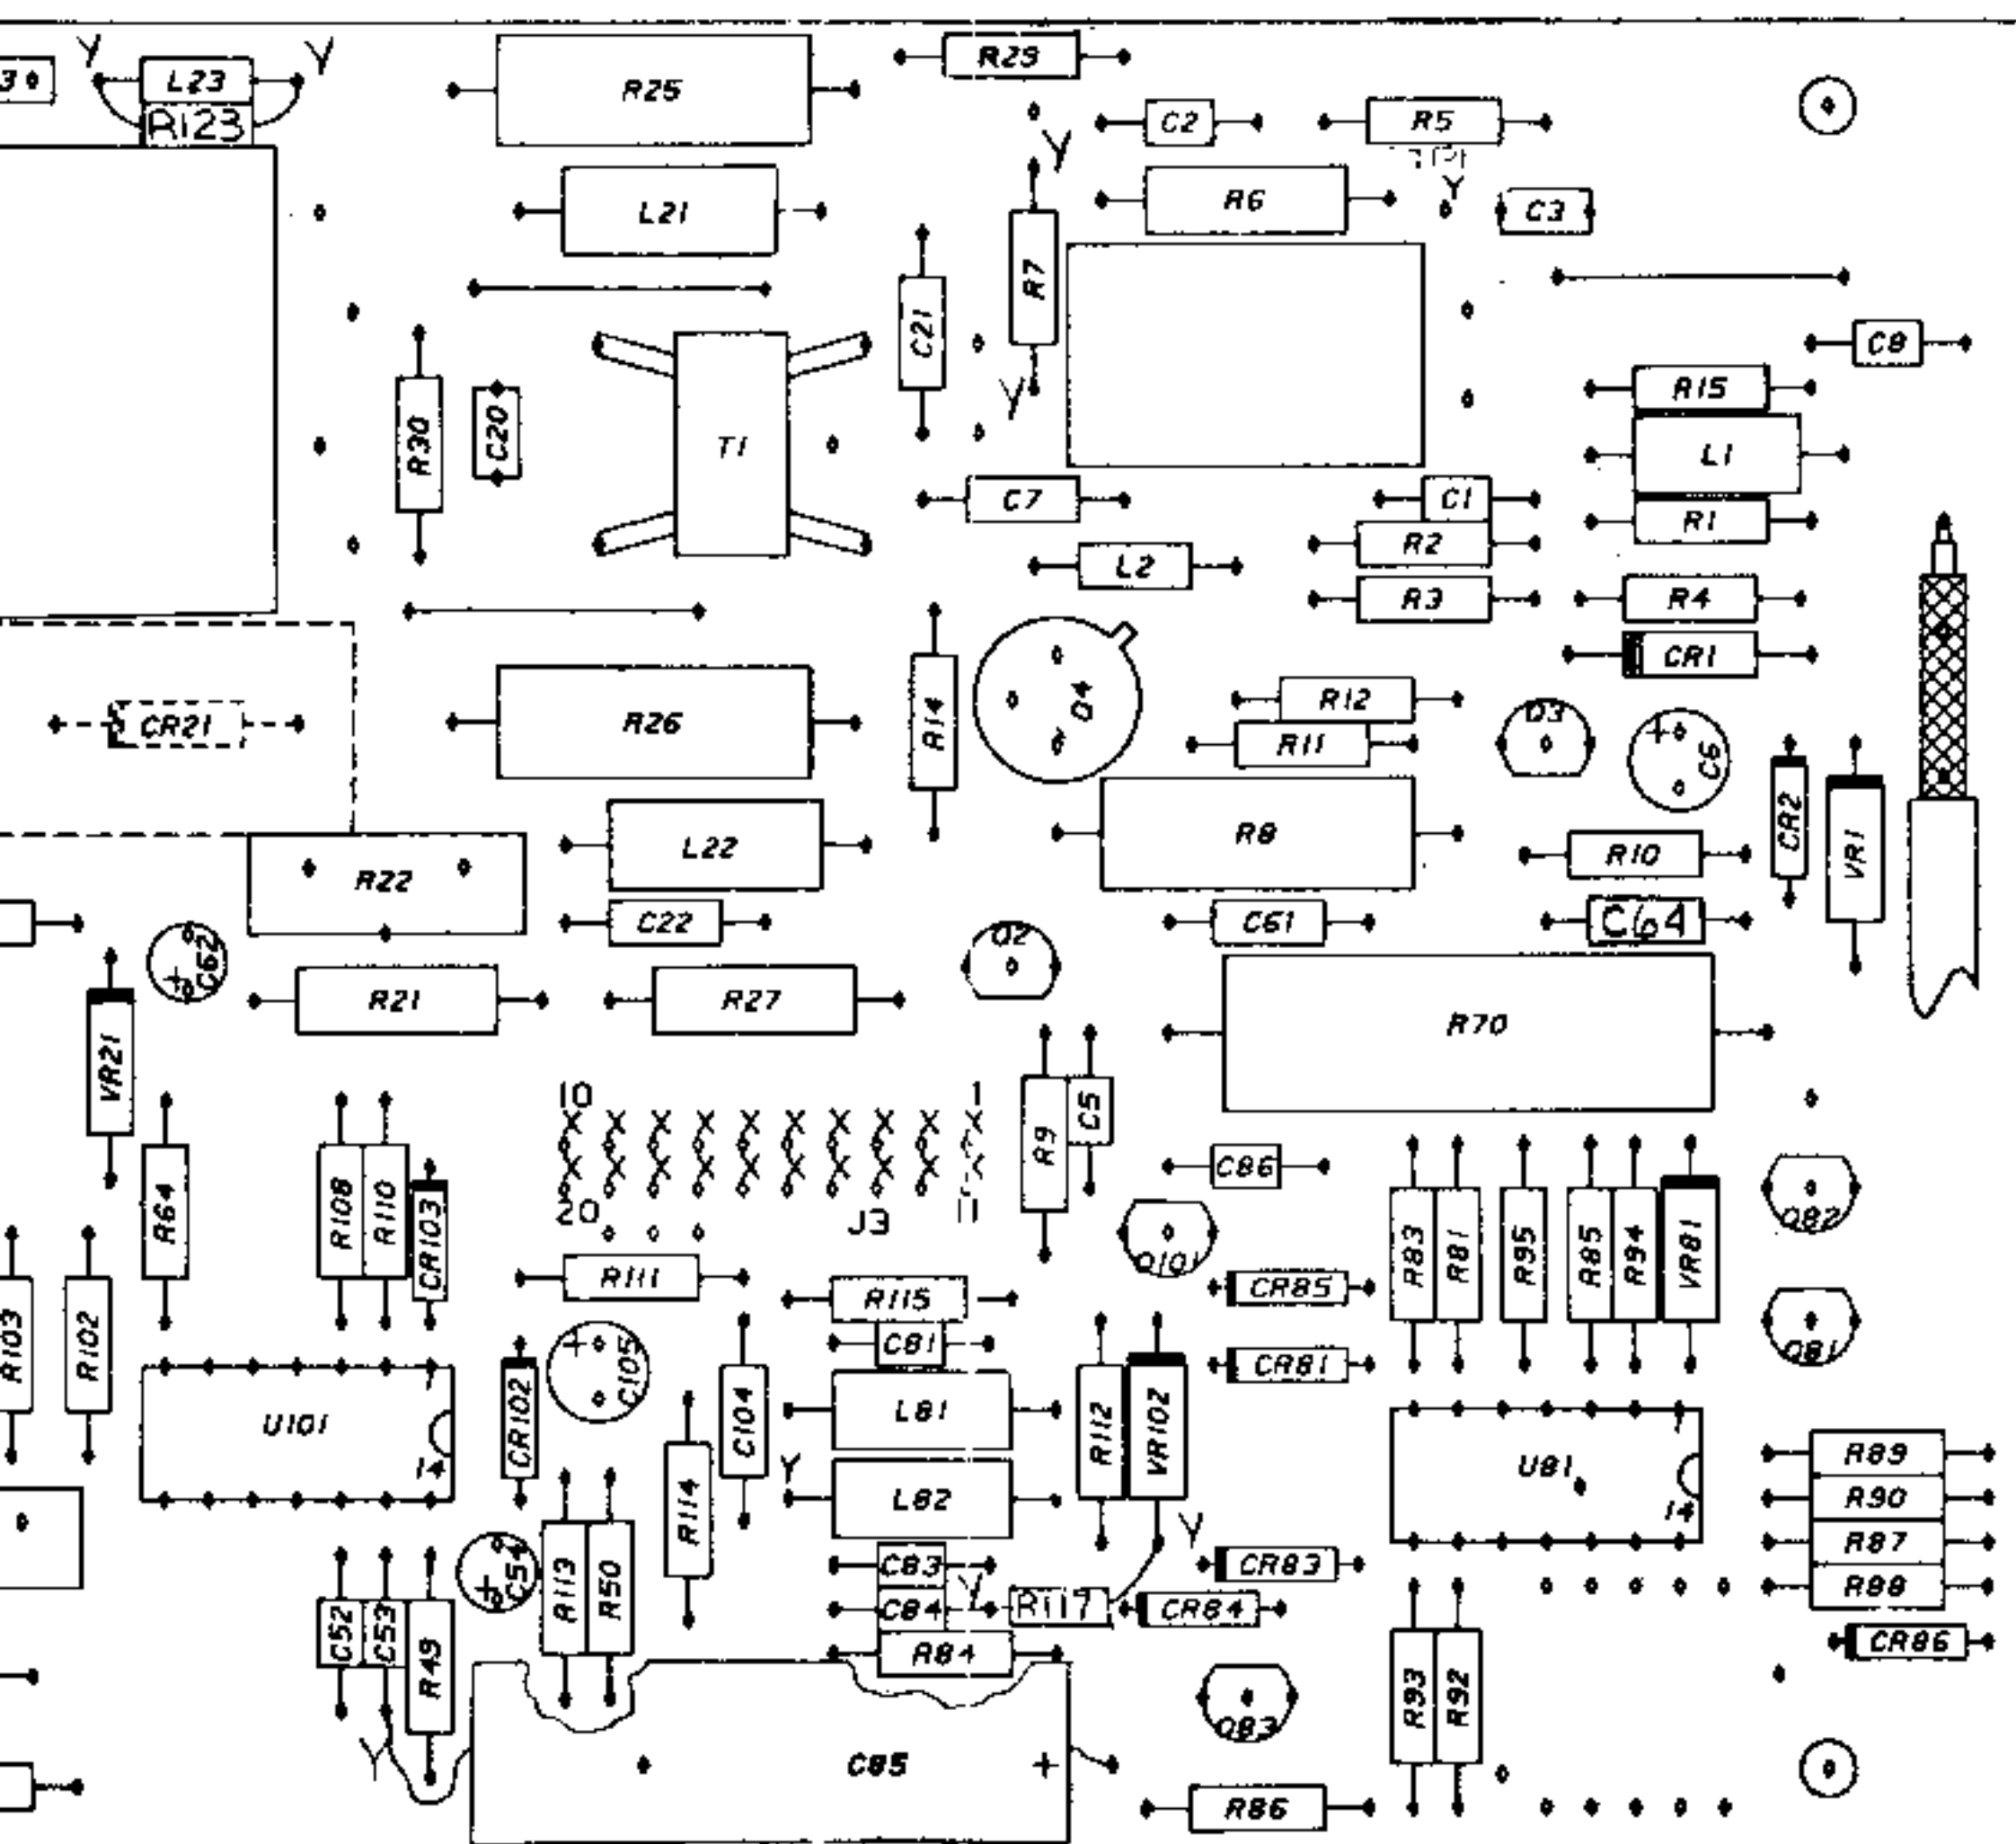
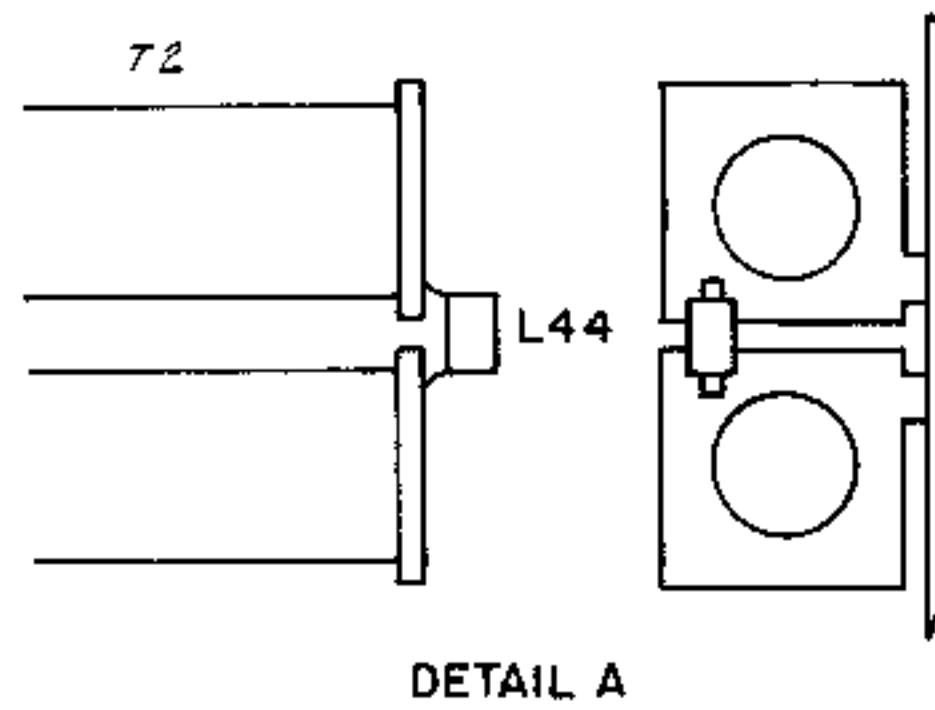
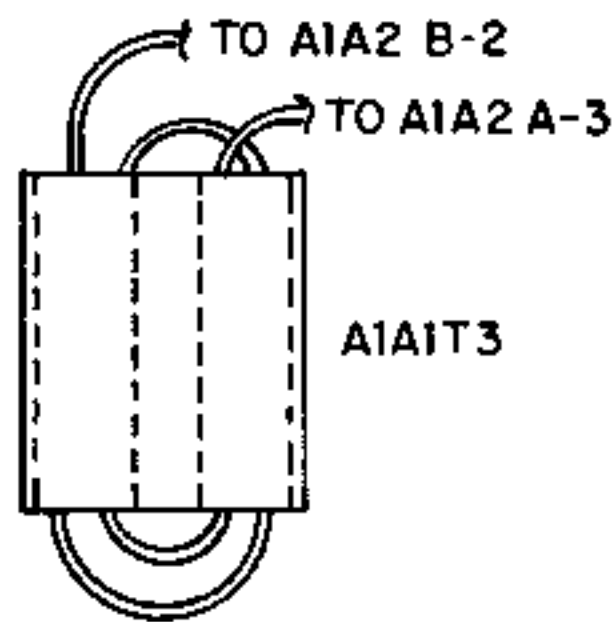
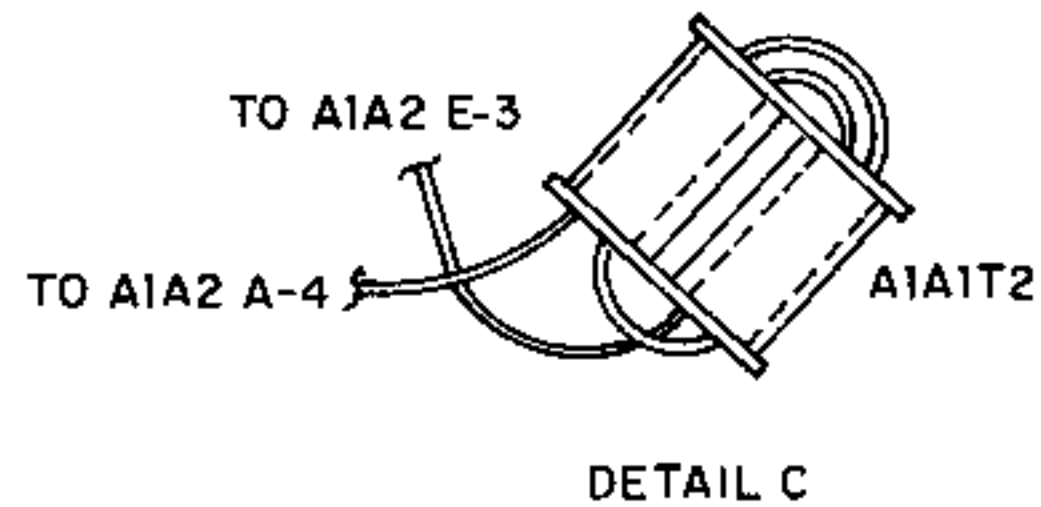
Power Amplifier A1A1,  
After Modification  
Figure 1 (Sheet 2)

NOTE: LEADS FROM T2 AND T3 MUST BE CAREFULLY POSITIONED AS SHOWN TO PREVENT DESTRUCTIVE OSCILLATION.

- K. Install 100- $\Omega$  resistor R124 (745-1310-000) in parallel with L24. Wrap the resistor leads around the coil leads and solder.
- L. Examine transistors Q41A/B and resistor R7. If Q41 was manufactured by Motorola, the value of R7 should be 15  $\Omega$ . If Q41 was manufactured by CTC, the value of R7 should be 27  $\Omega$ . If it is necessary to replace R7, cut the resistor leads close to component body, leaving the leads soldered into the circuit card. Install the new resistor (15  $\Omega$ , 745-0683-000, or 27  $\Omega$ , 745-0692-000), attaching the leads to the old resistor leads.

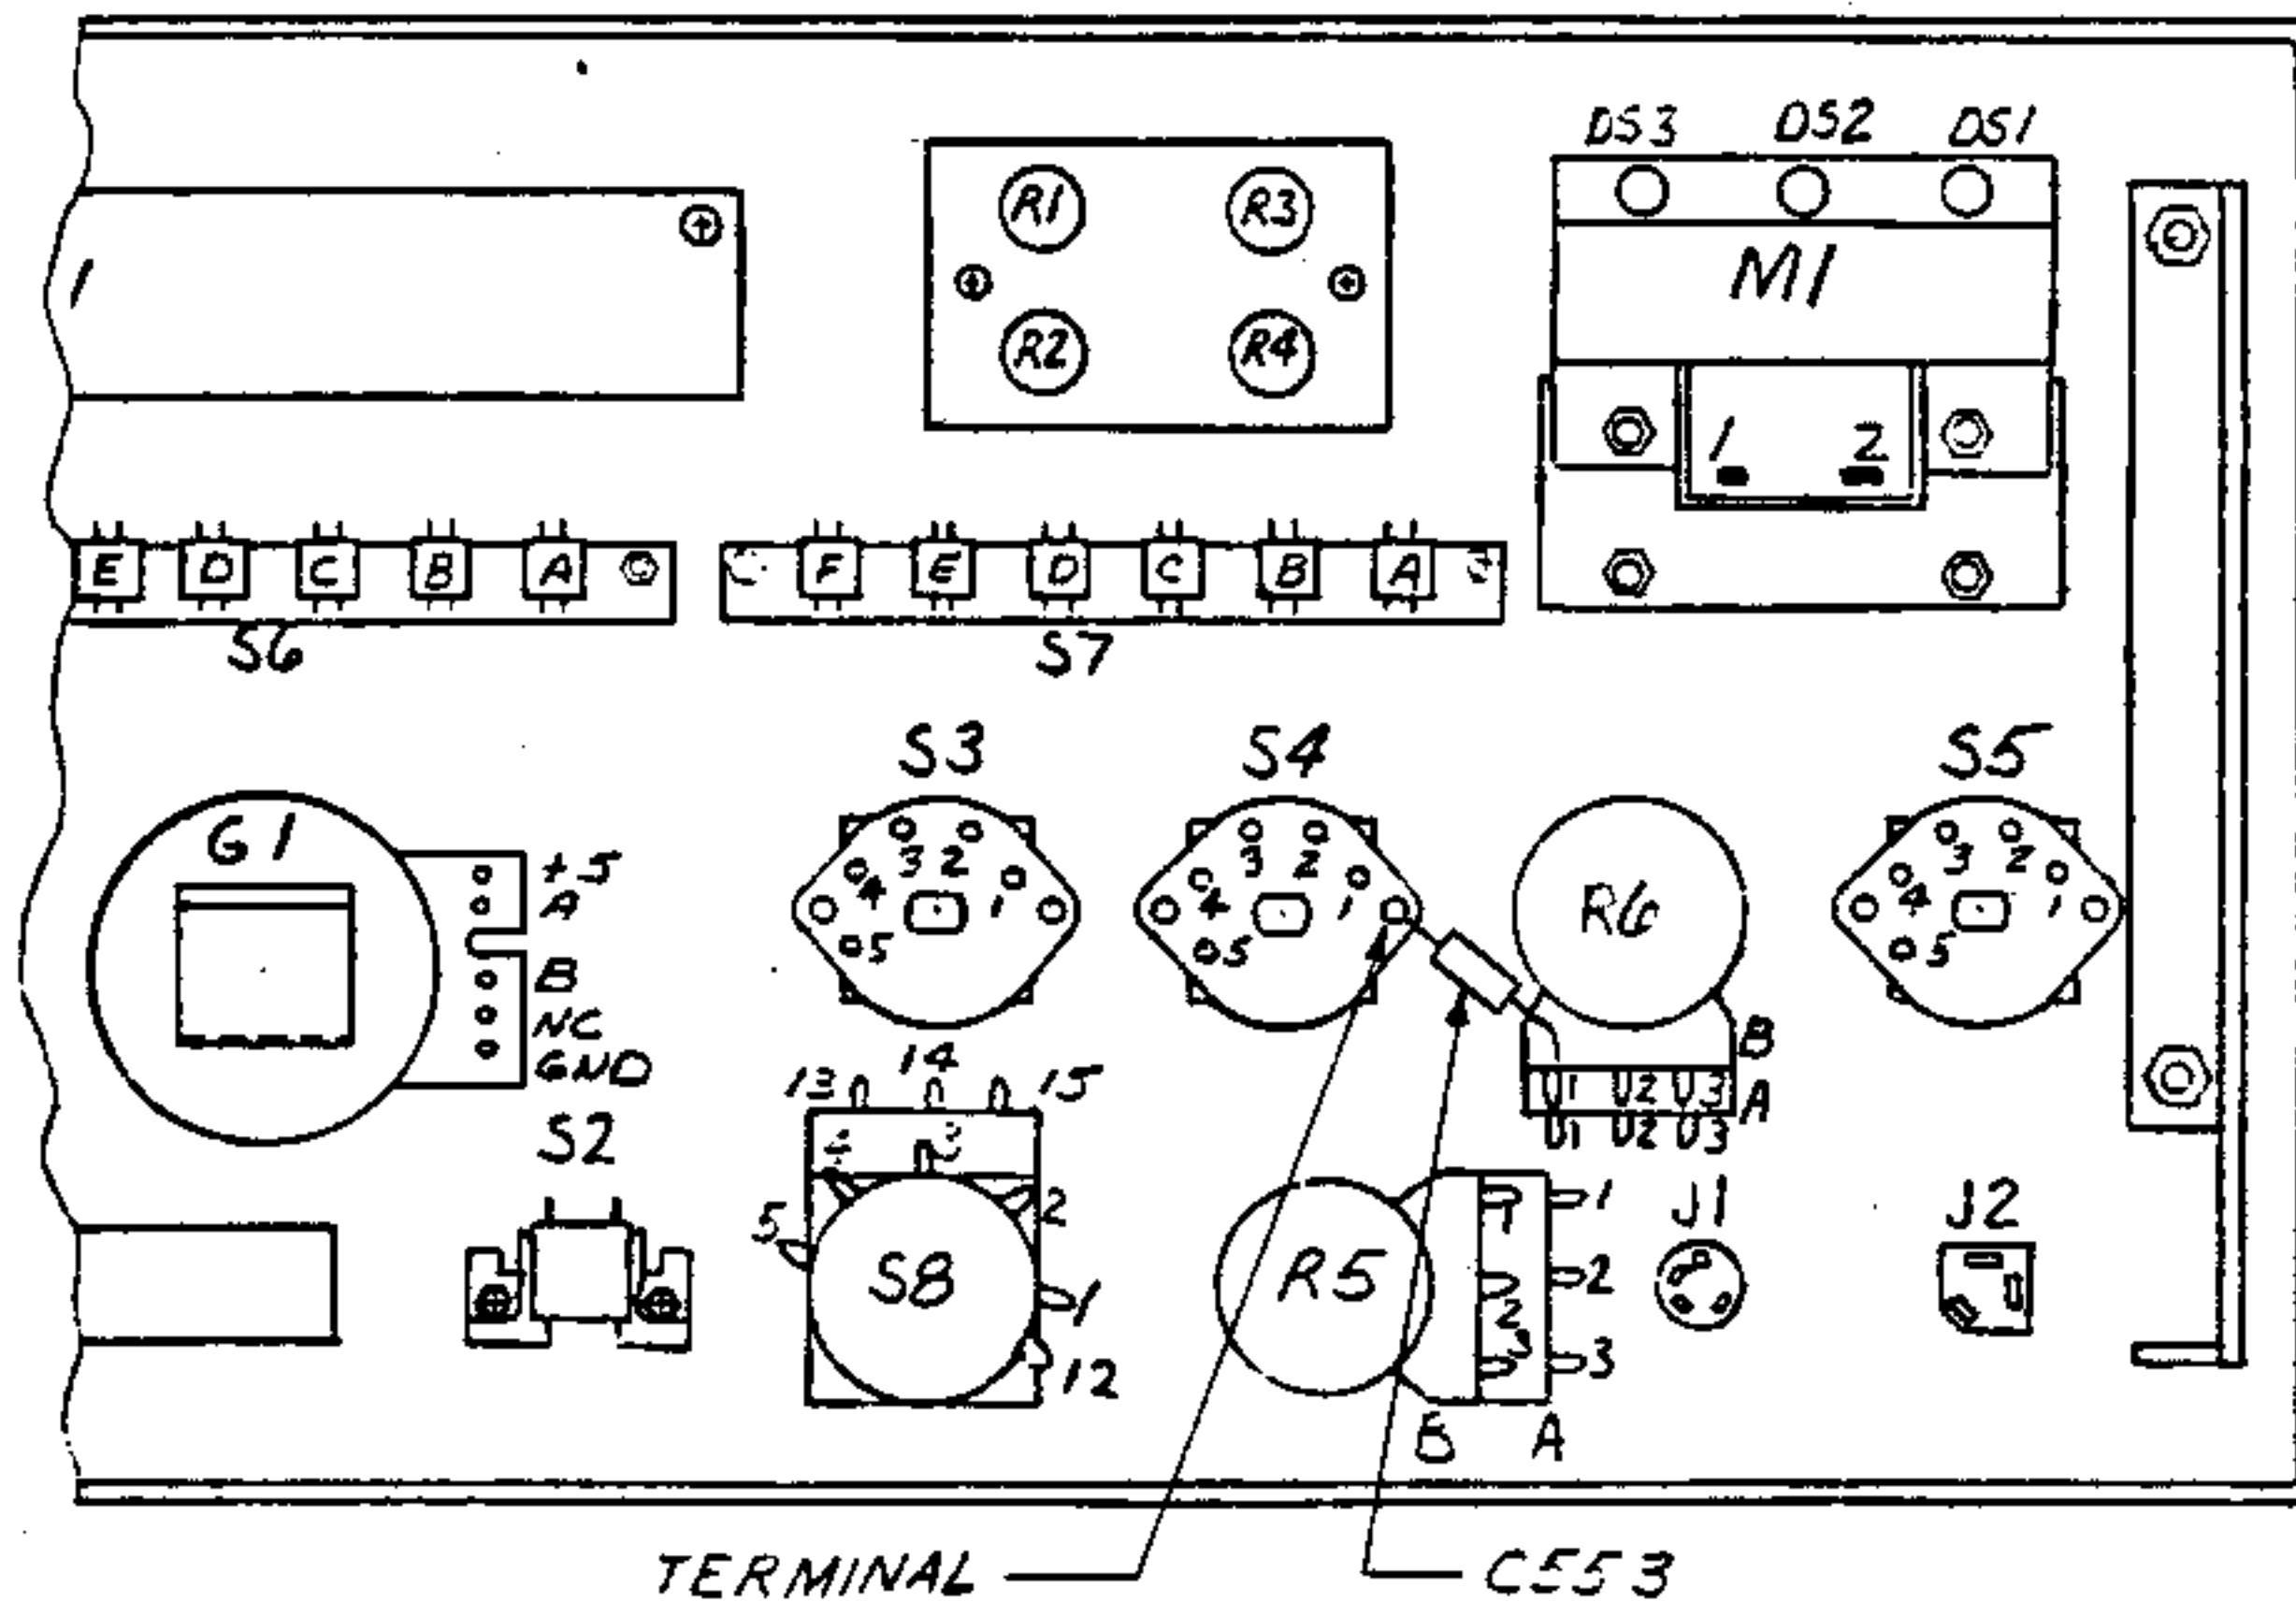
P/O Front Panel Assembly A10  
Figure 2

**NOTE:** Refer to figure 2 while performing steps F through H. Capacitor C553 is part of receiver-exciter assembly A3 but is mounted on front panel assembly A10. If C553 were mounted on the A3 card, a circuit trace cut on the bottom of the card would be required making it necessary to remove the card from the radio. Refer to figure 3 for a schematic diagram which shows the location of C553.

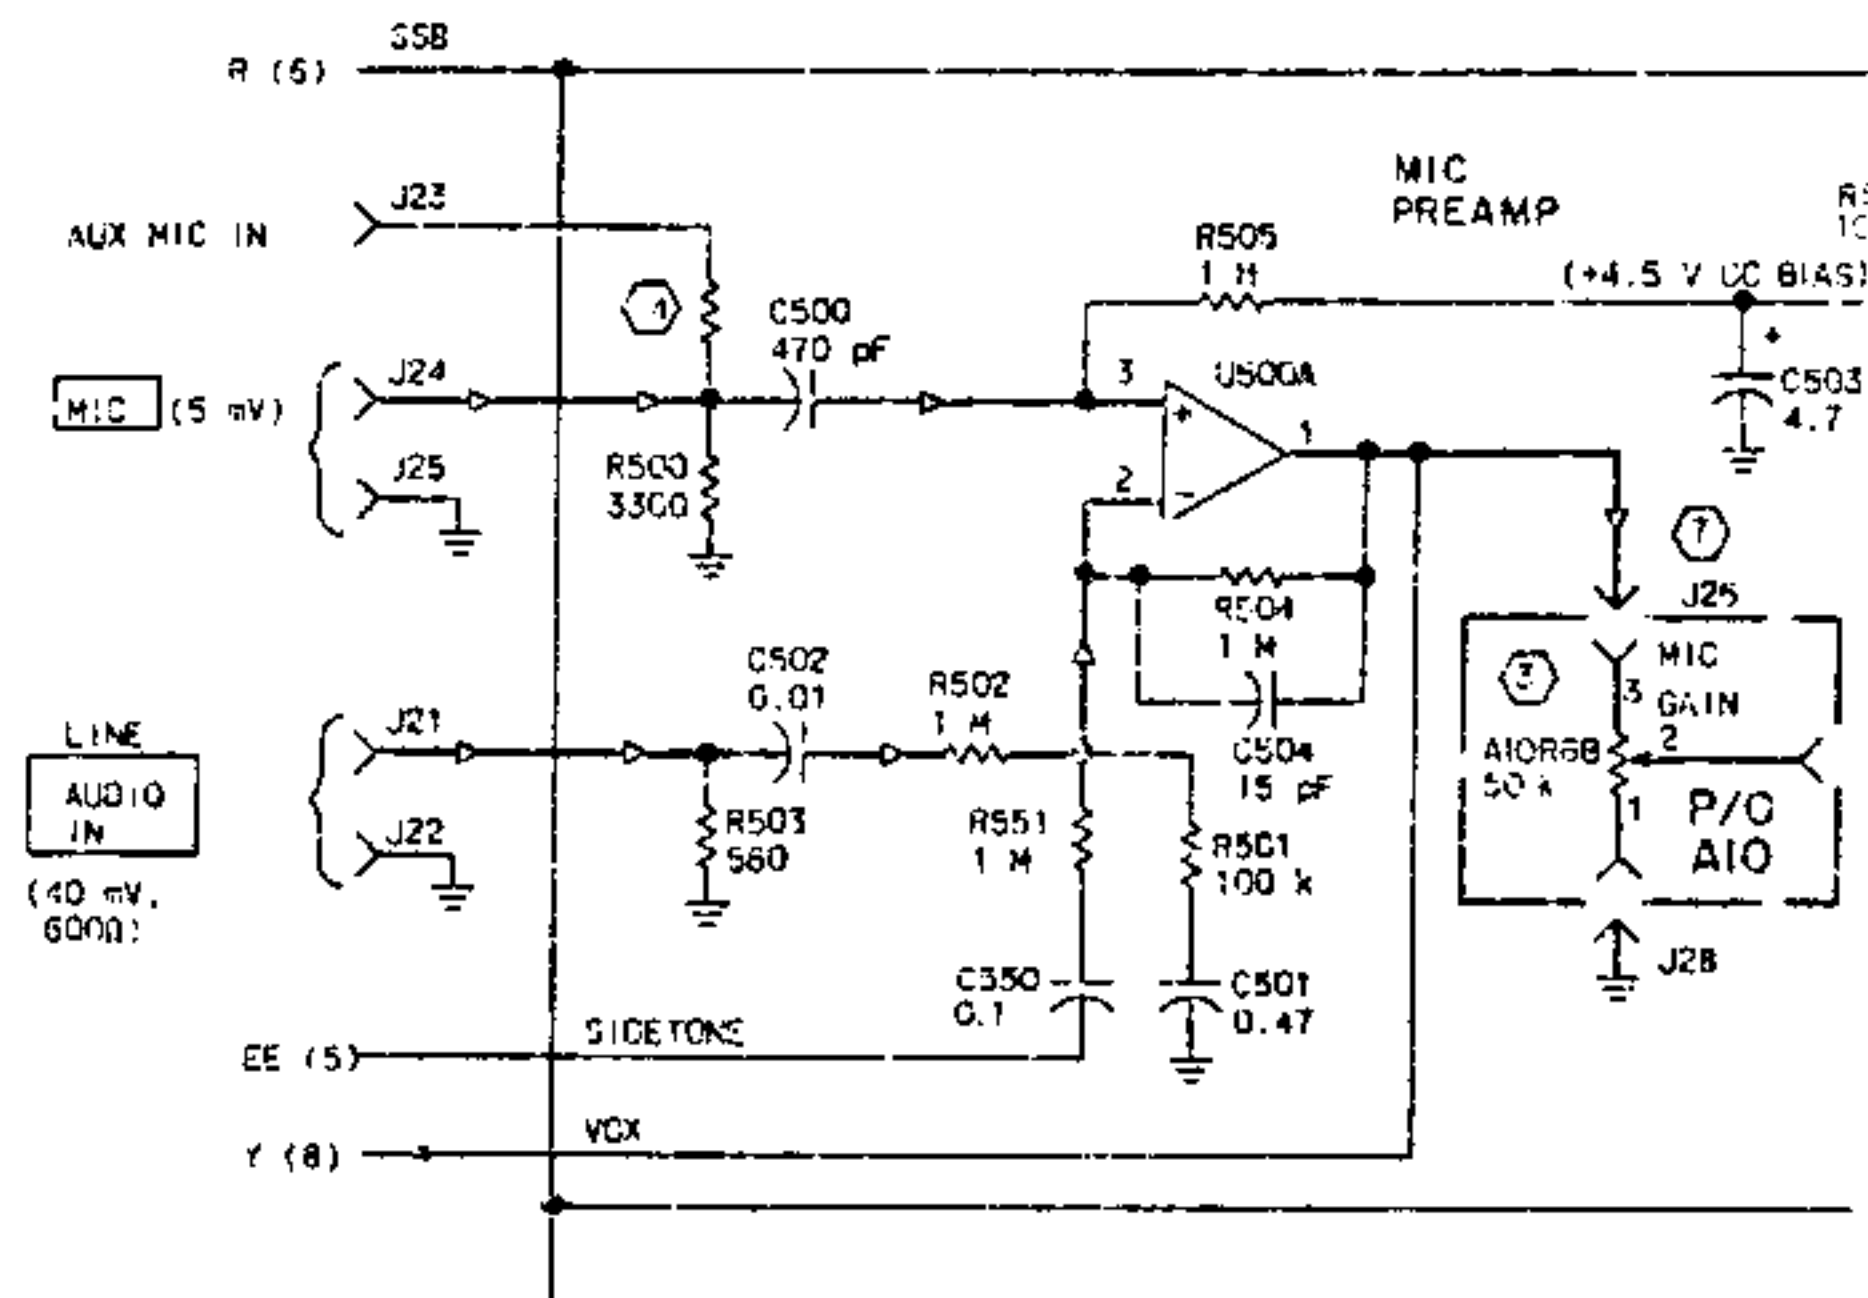
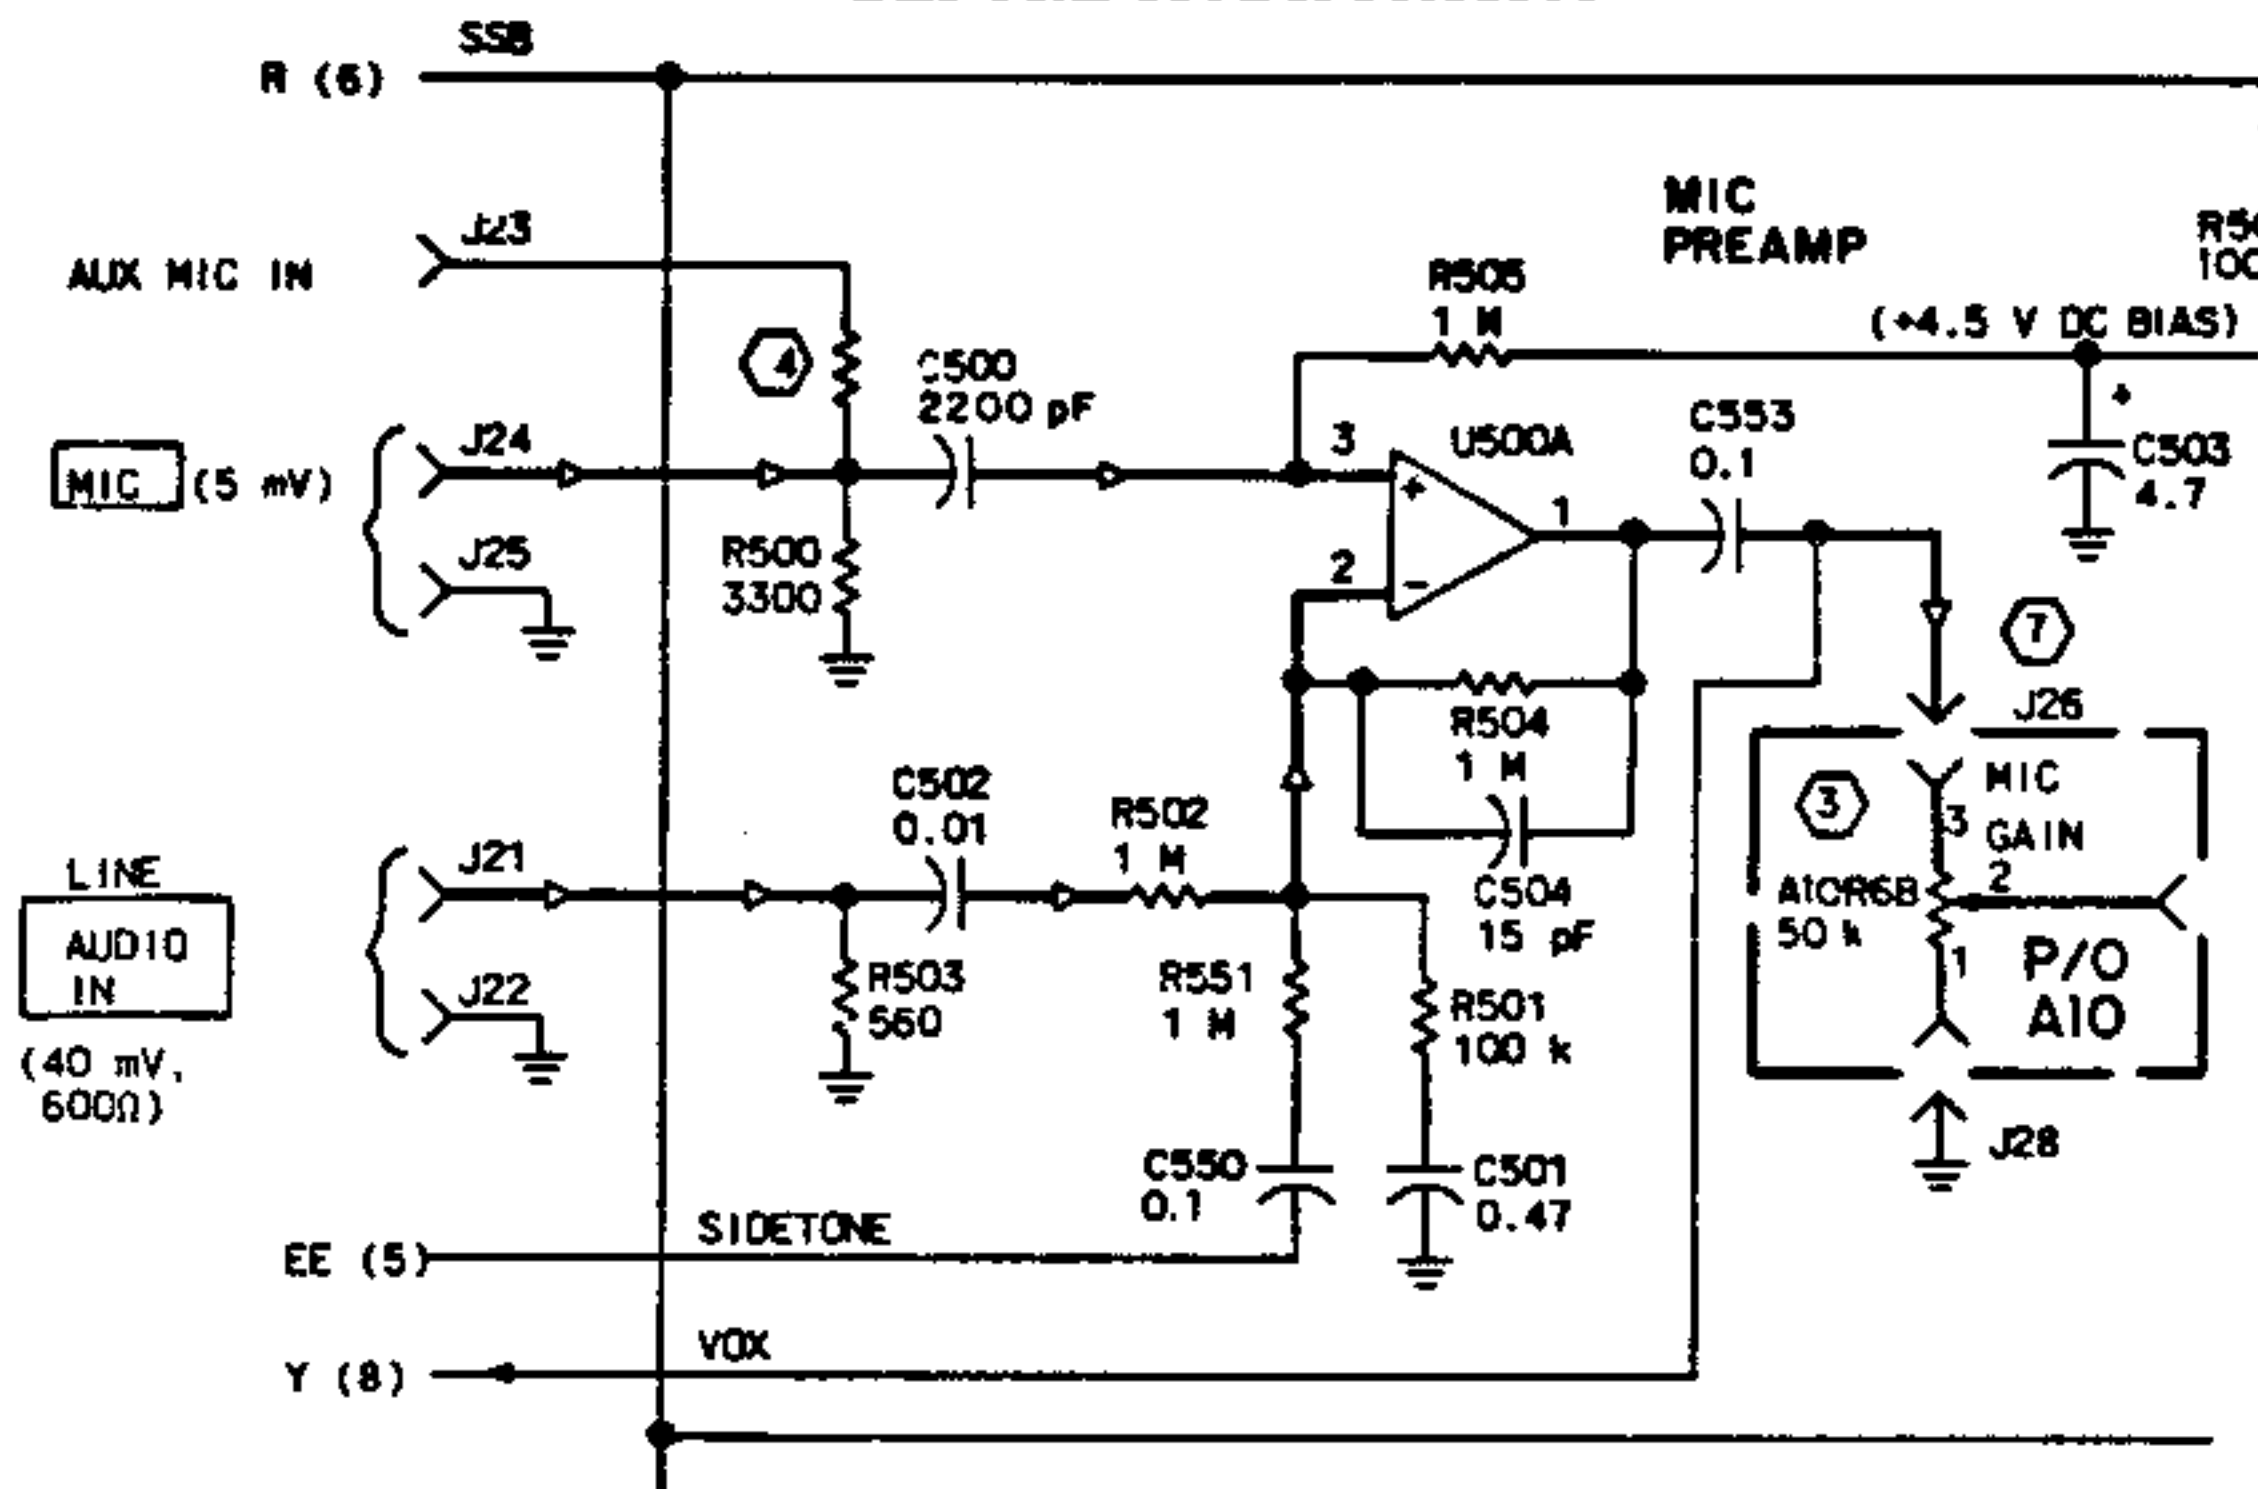
P/O Receiver-Exciter Assembly A3,  
Schematic Diagram  
Figure 3

BEFORE MODIFICATION

AFTER MODIFICATION

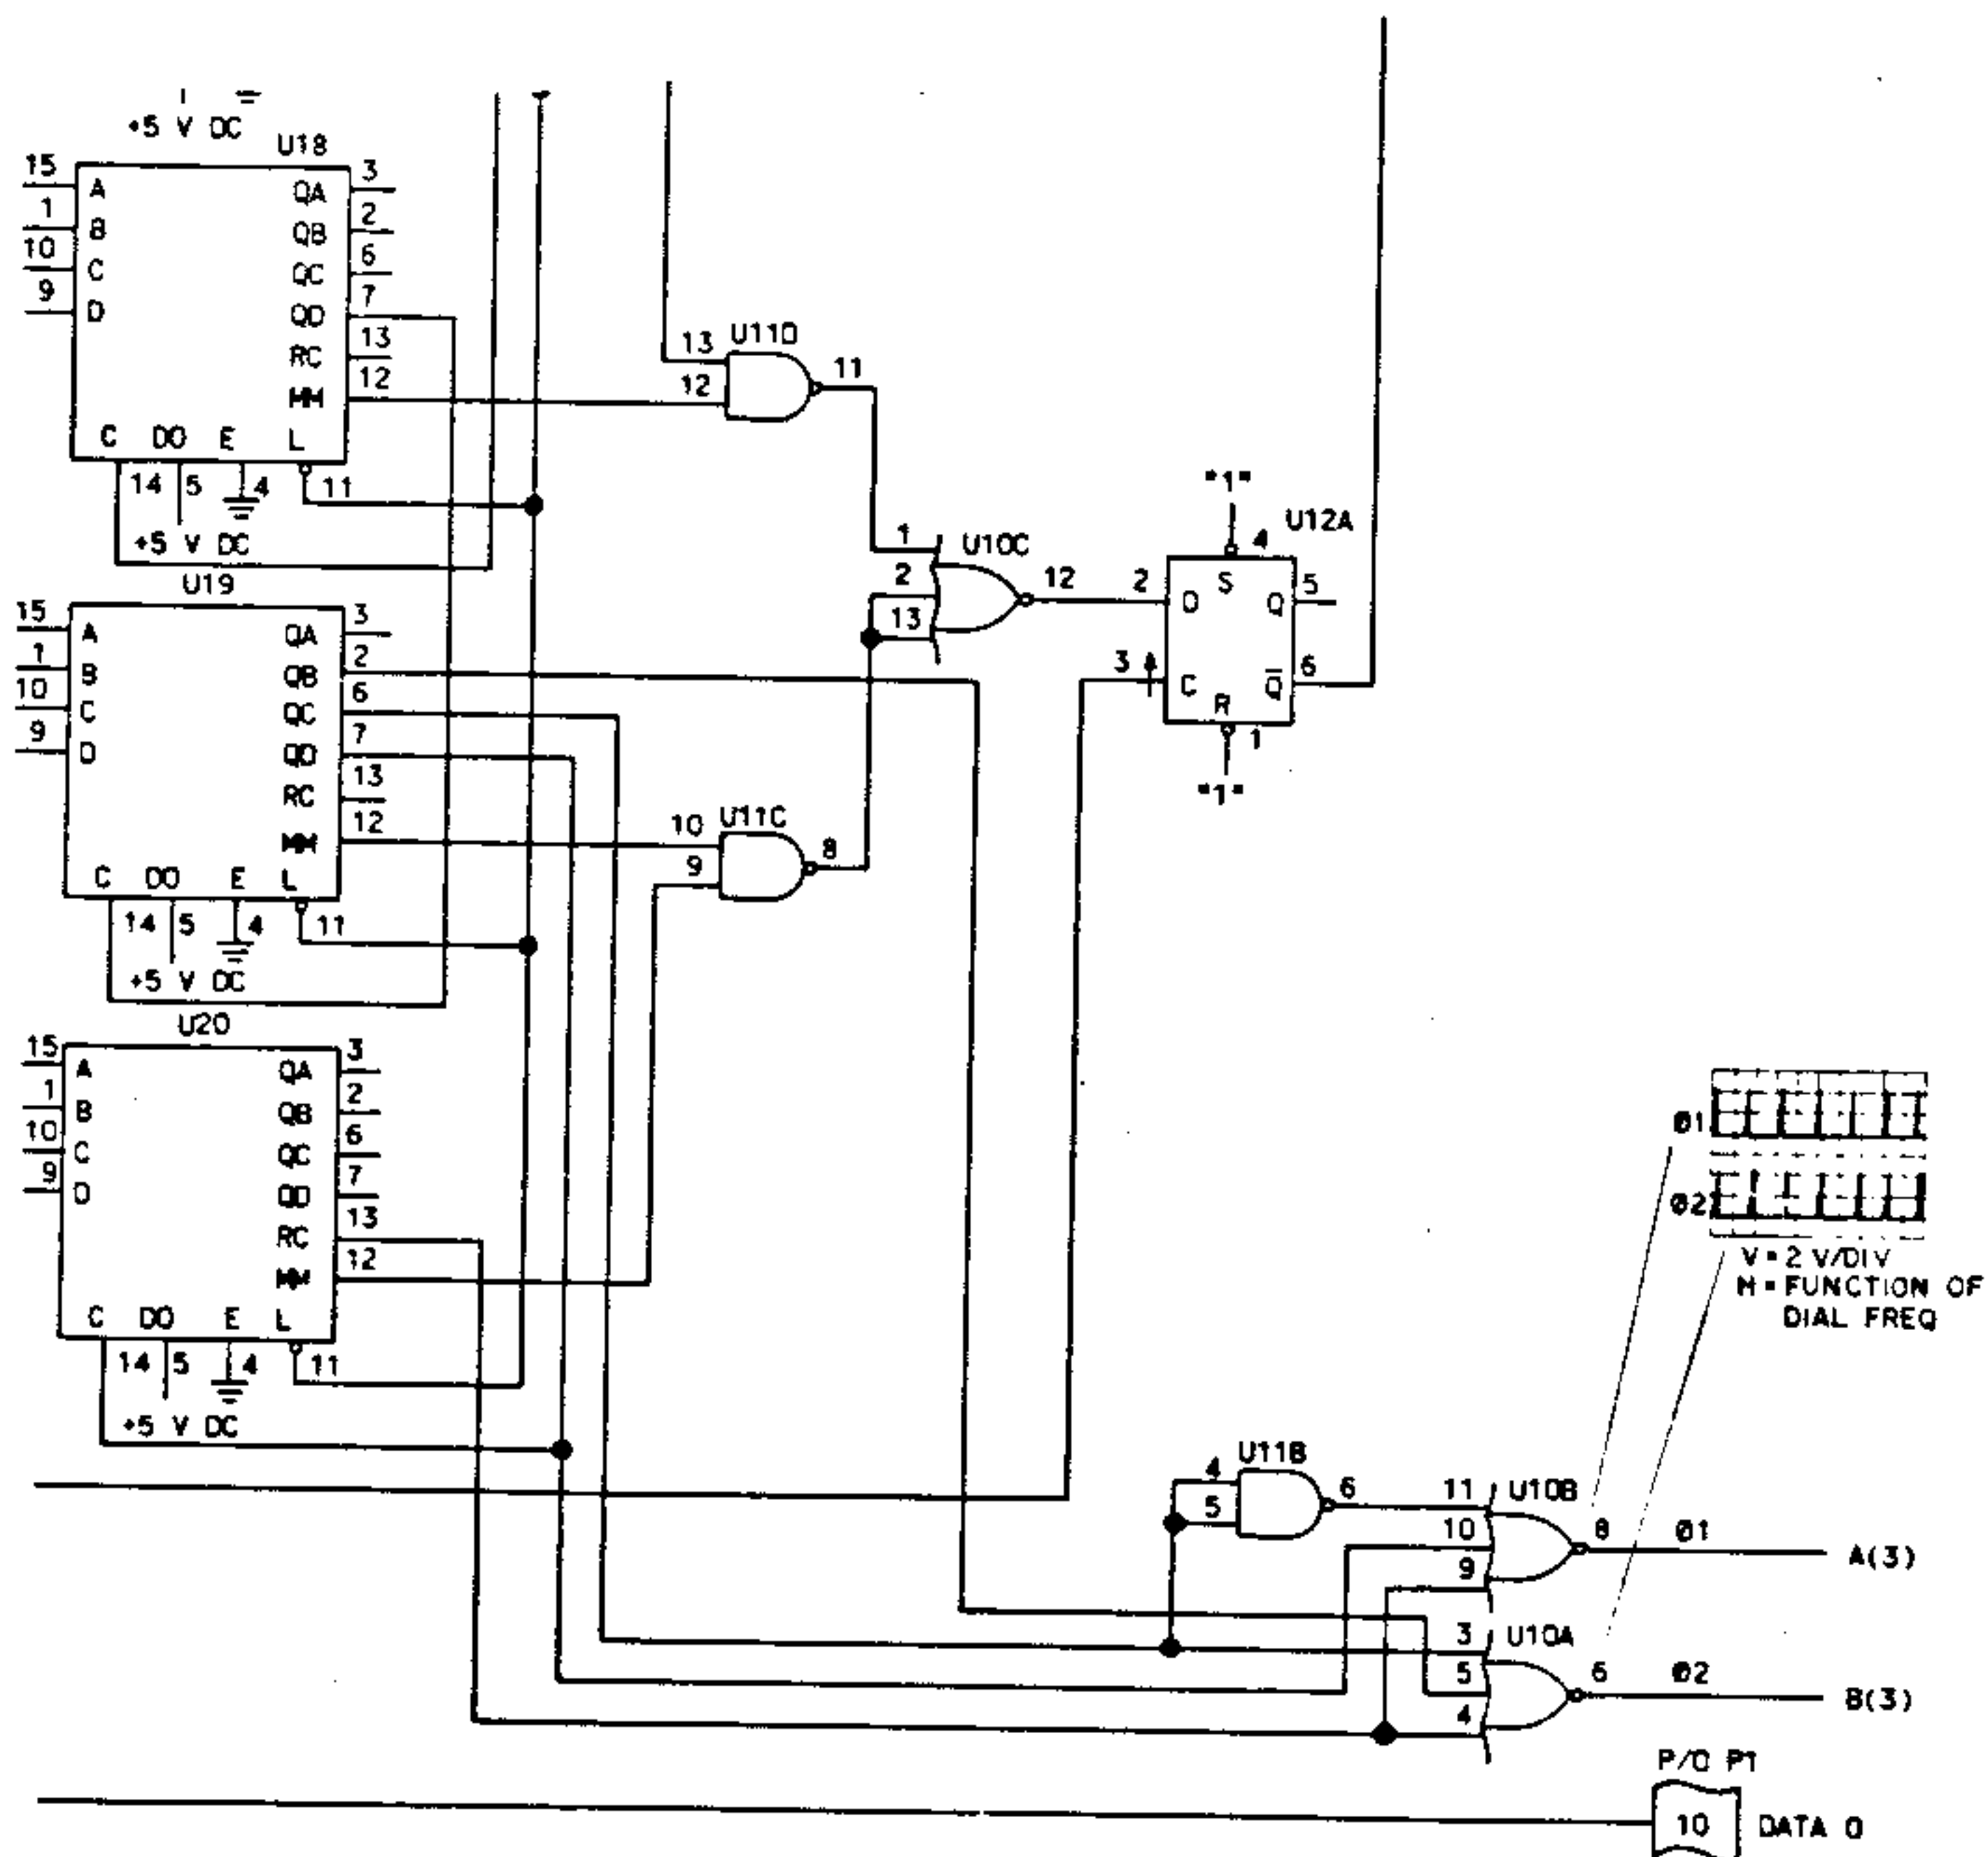
P/O Synthesizer Variable Reference Frequency Loop A5A2, Schematic Diagram  
Figure 2

A frequency warble may occur at certain frequencies in some radios. The warble will usually occur at the top end of each 1-MHz band. The problem has been traced to two integrated circuits on synthesizer variable frequency loop A5A2. When U14 and U26 are at the low end of their specified parameters, a low rf input may cause them to miscount. Steps F through L of the modification procedure will correct this problem.

The synthesizer 500-Hz sidebands can be observed as a false signal 500 Hz away from a strong cw carrier when tuning with a narrow cw crystal filter. This service bulletin (steps M and N of the modification procedure) reduces the 500-Hz sideband level on the synthesizer output (first receiver mixer local oscillator).

- F. Remove 4-pF capacitor C40 and replace it with a 12-pF capacitor (912-4141-120).
- G. Remove 4-pF capacitor C45 and replace it with a 12-pF capacitor (912-4141-120).
- H. Remove transistor Q9 (2N5486) and replace it with a 2N5397 transistor (352-0998-010).
- I. Remove 0.15- $\mu$ H coil L6 and replace it with a 0.10- $\mu$ H coil (240-2723-140).
- J. Remove 0.15- $\mu$ H coil L7 and replace it with a 0.10- $\mu$ H coil (240-2723-140).
- K. Remove 47-pF capacitor C50 and replace it with a 27-pF capacitor (913-1098-570).
- L. Remove 154- $\Omega$  resistor R24 and replace it with a 56- $\Omega$  resistor (745-0704-000).
- M. On the bottom of the card, cut the circuit trace which connects U10-5 to U10-10.
- N. Install a jumper wire (428-0282-050) from U19-2 to U10-5 on the bottom of the card.
- O. Mark SB 16 on the circuit card near the part number.
