KWM-380 TRANSCEIVER (622-5093-101)  
HF-380 TRANSCEIVER (622-3580-101)  
RECEIVER-EXCITER CIRCUIT CARD A3 (638-6908-001)

**SERVICE BULLETIN NO 1****PRODUCT IMPROVEMENT**

KWM-380 TRANSCEIVER (622-5093-001, -101)  
HF-380 TRANSCEIVER (622-3580-001, -101)  
SYNTHESIZER A5A1 (638-6916-001, -002)

## SERVICE BULLETIN NO 2

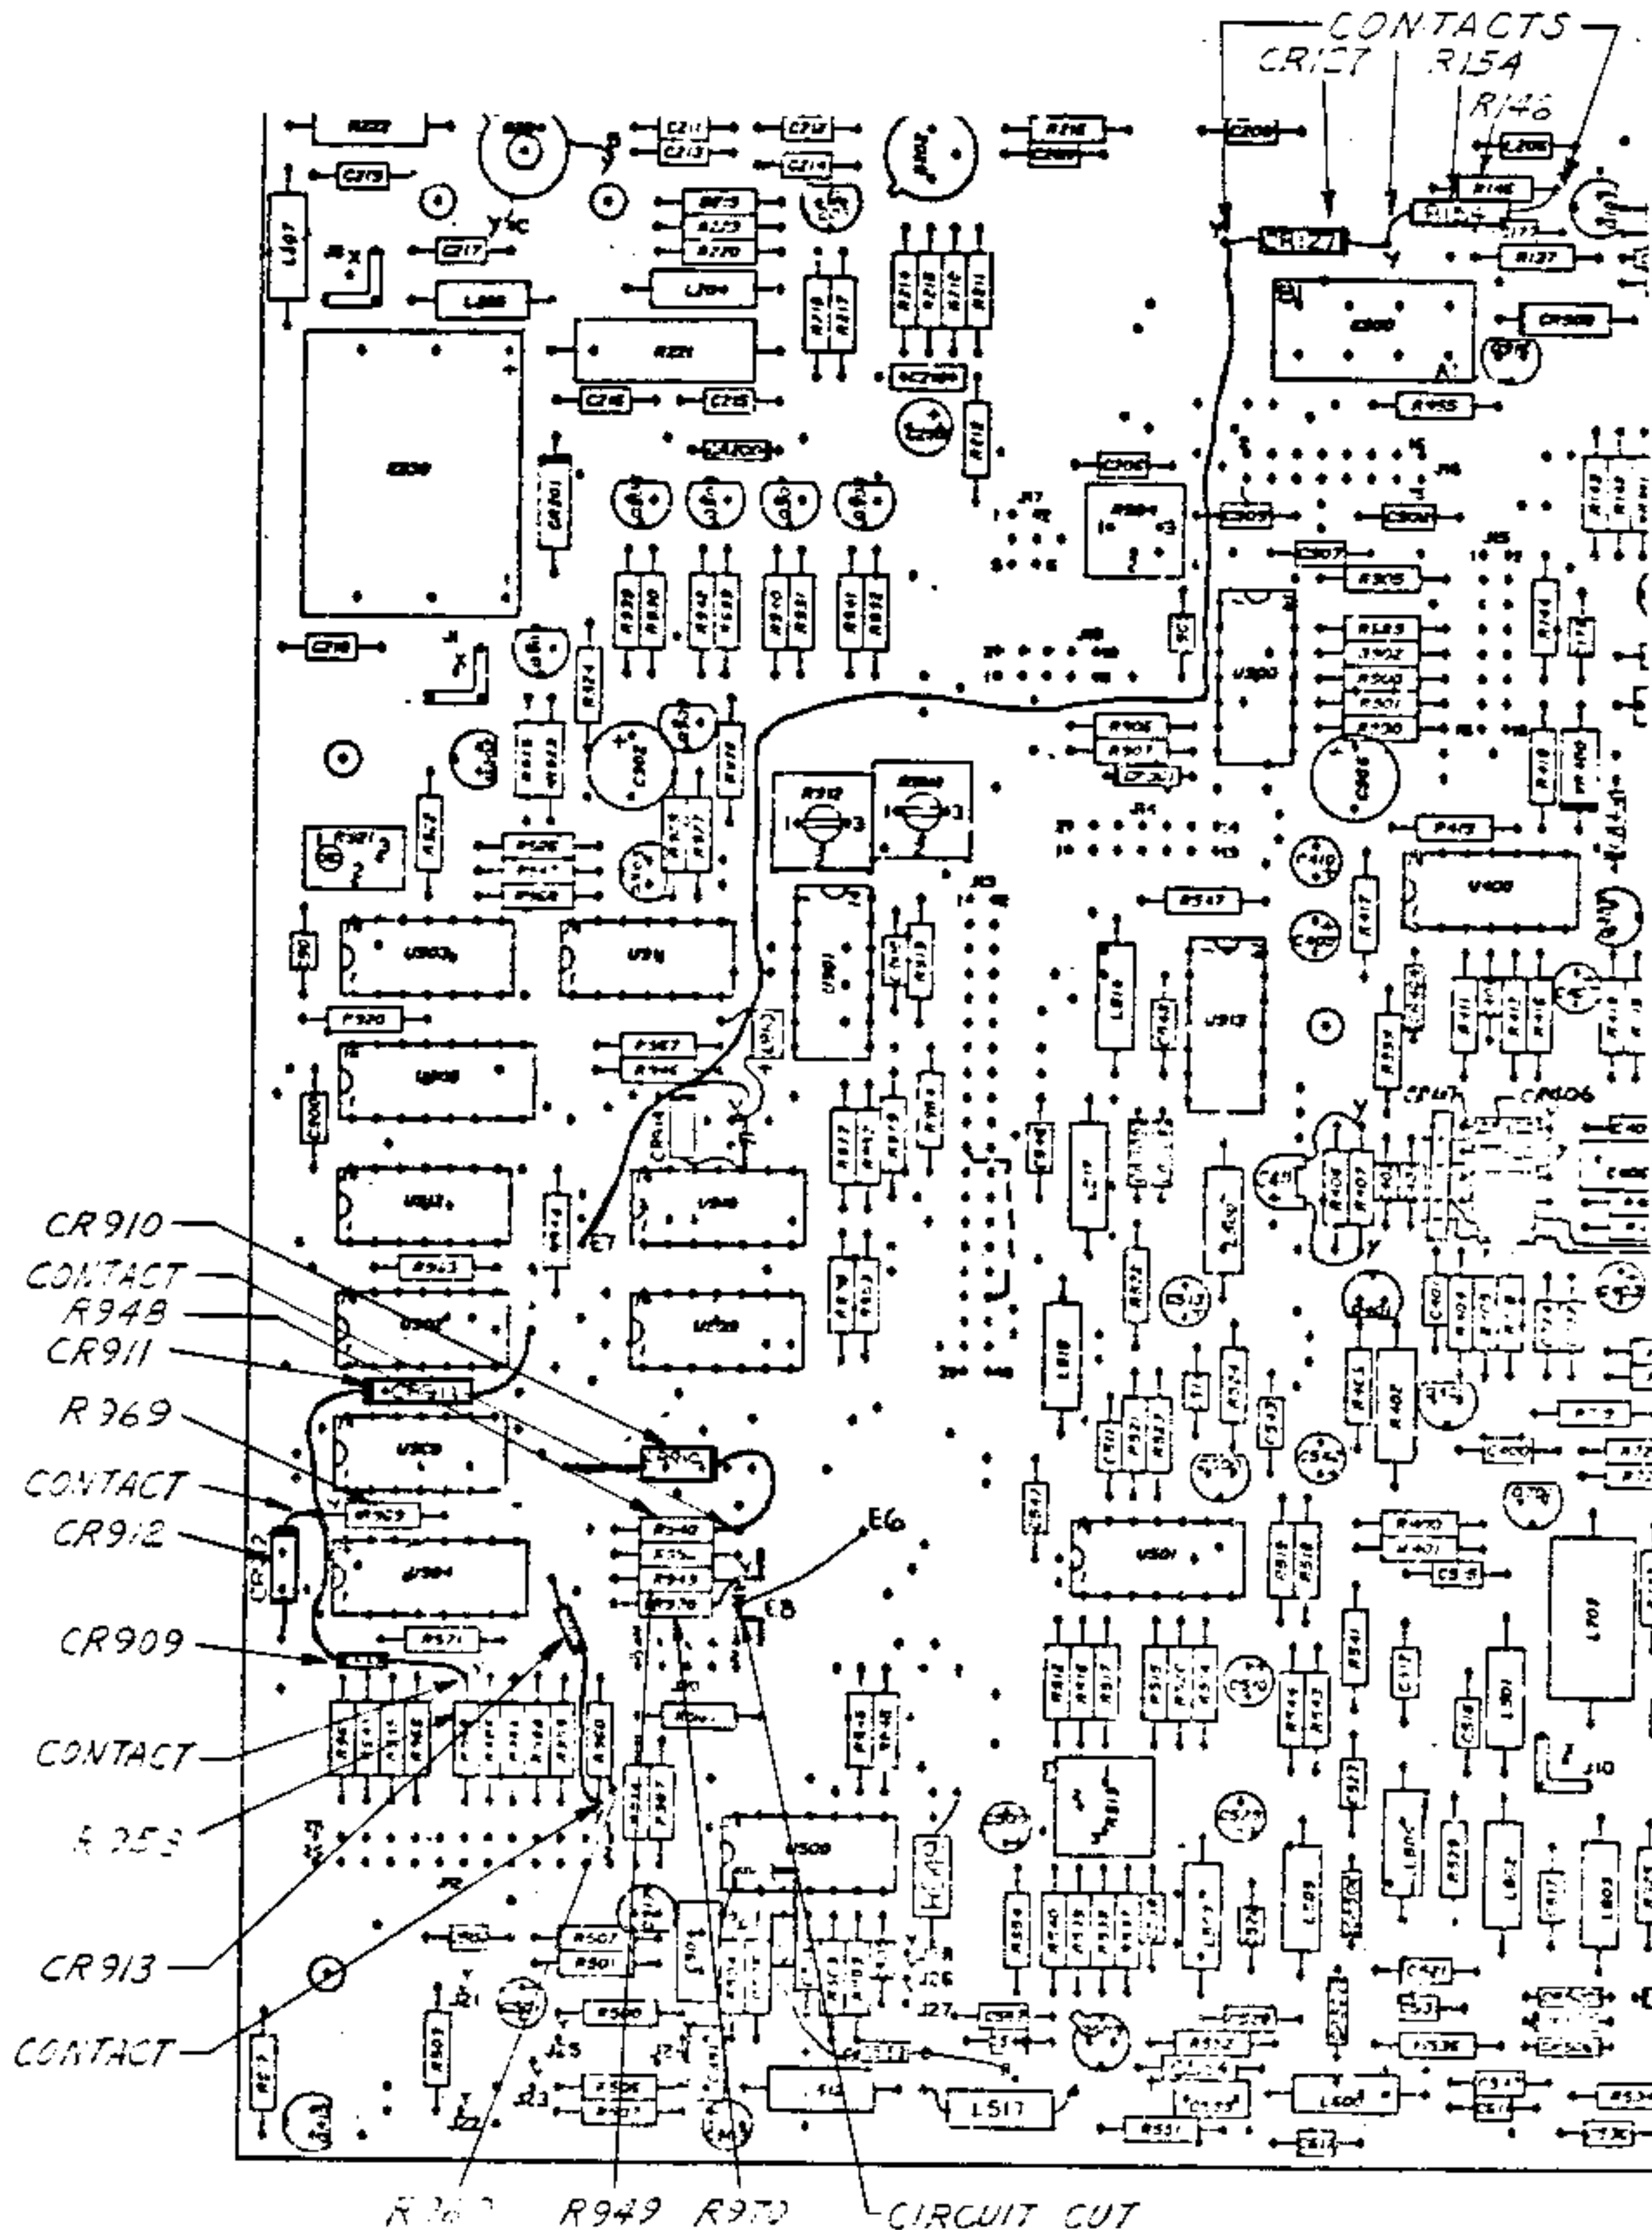
Figure 1

P/O Receiver-Exciter Circuit Card A3

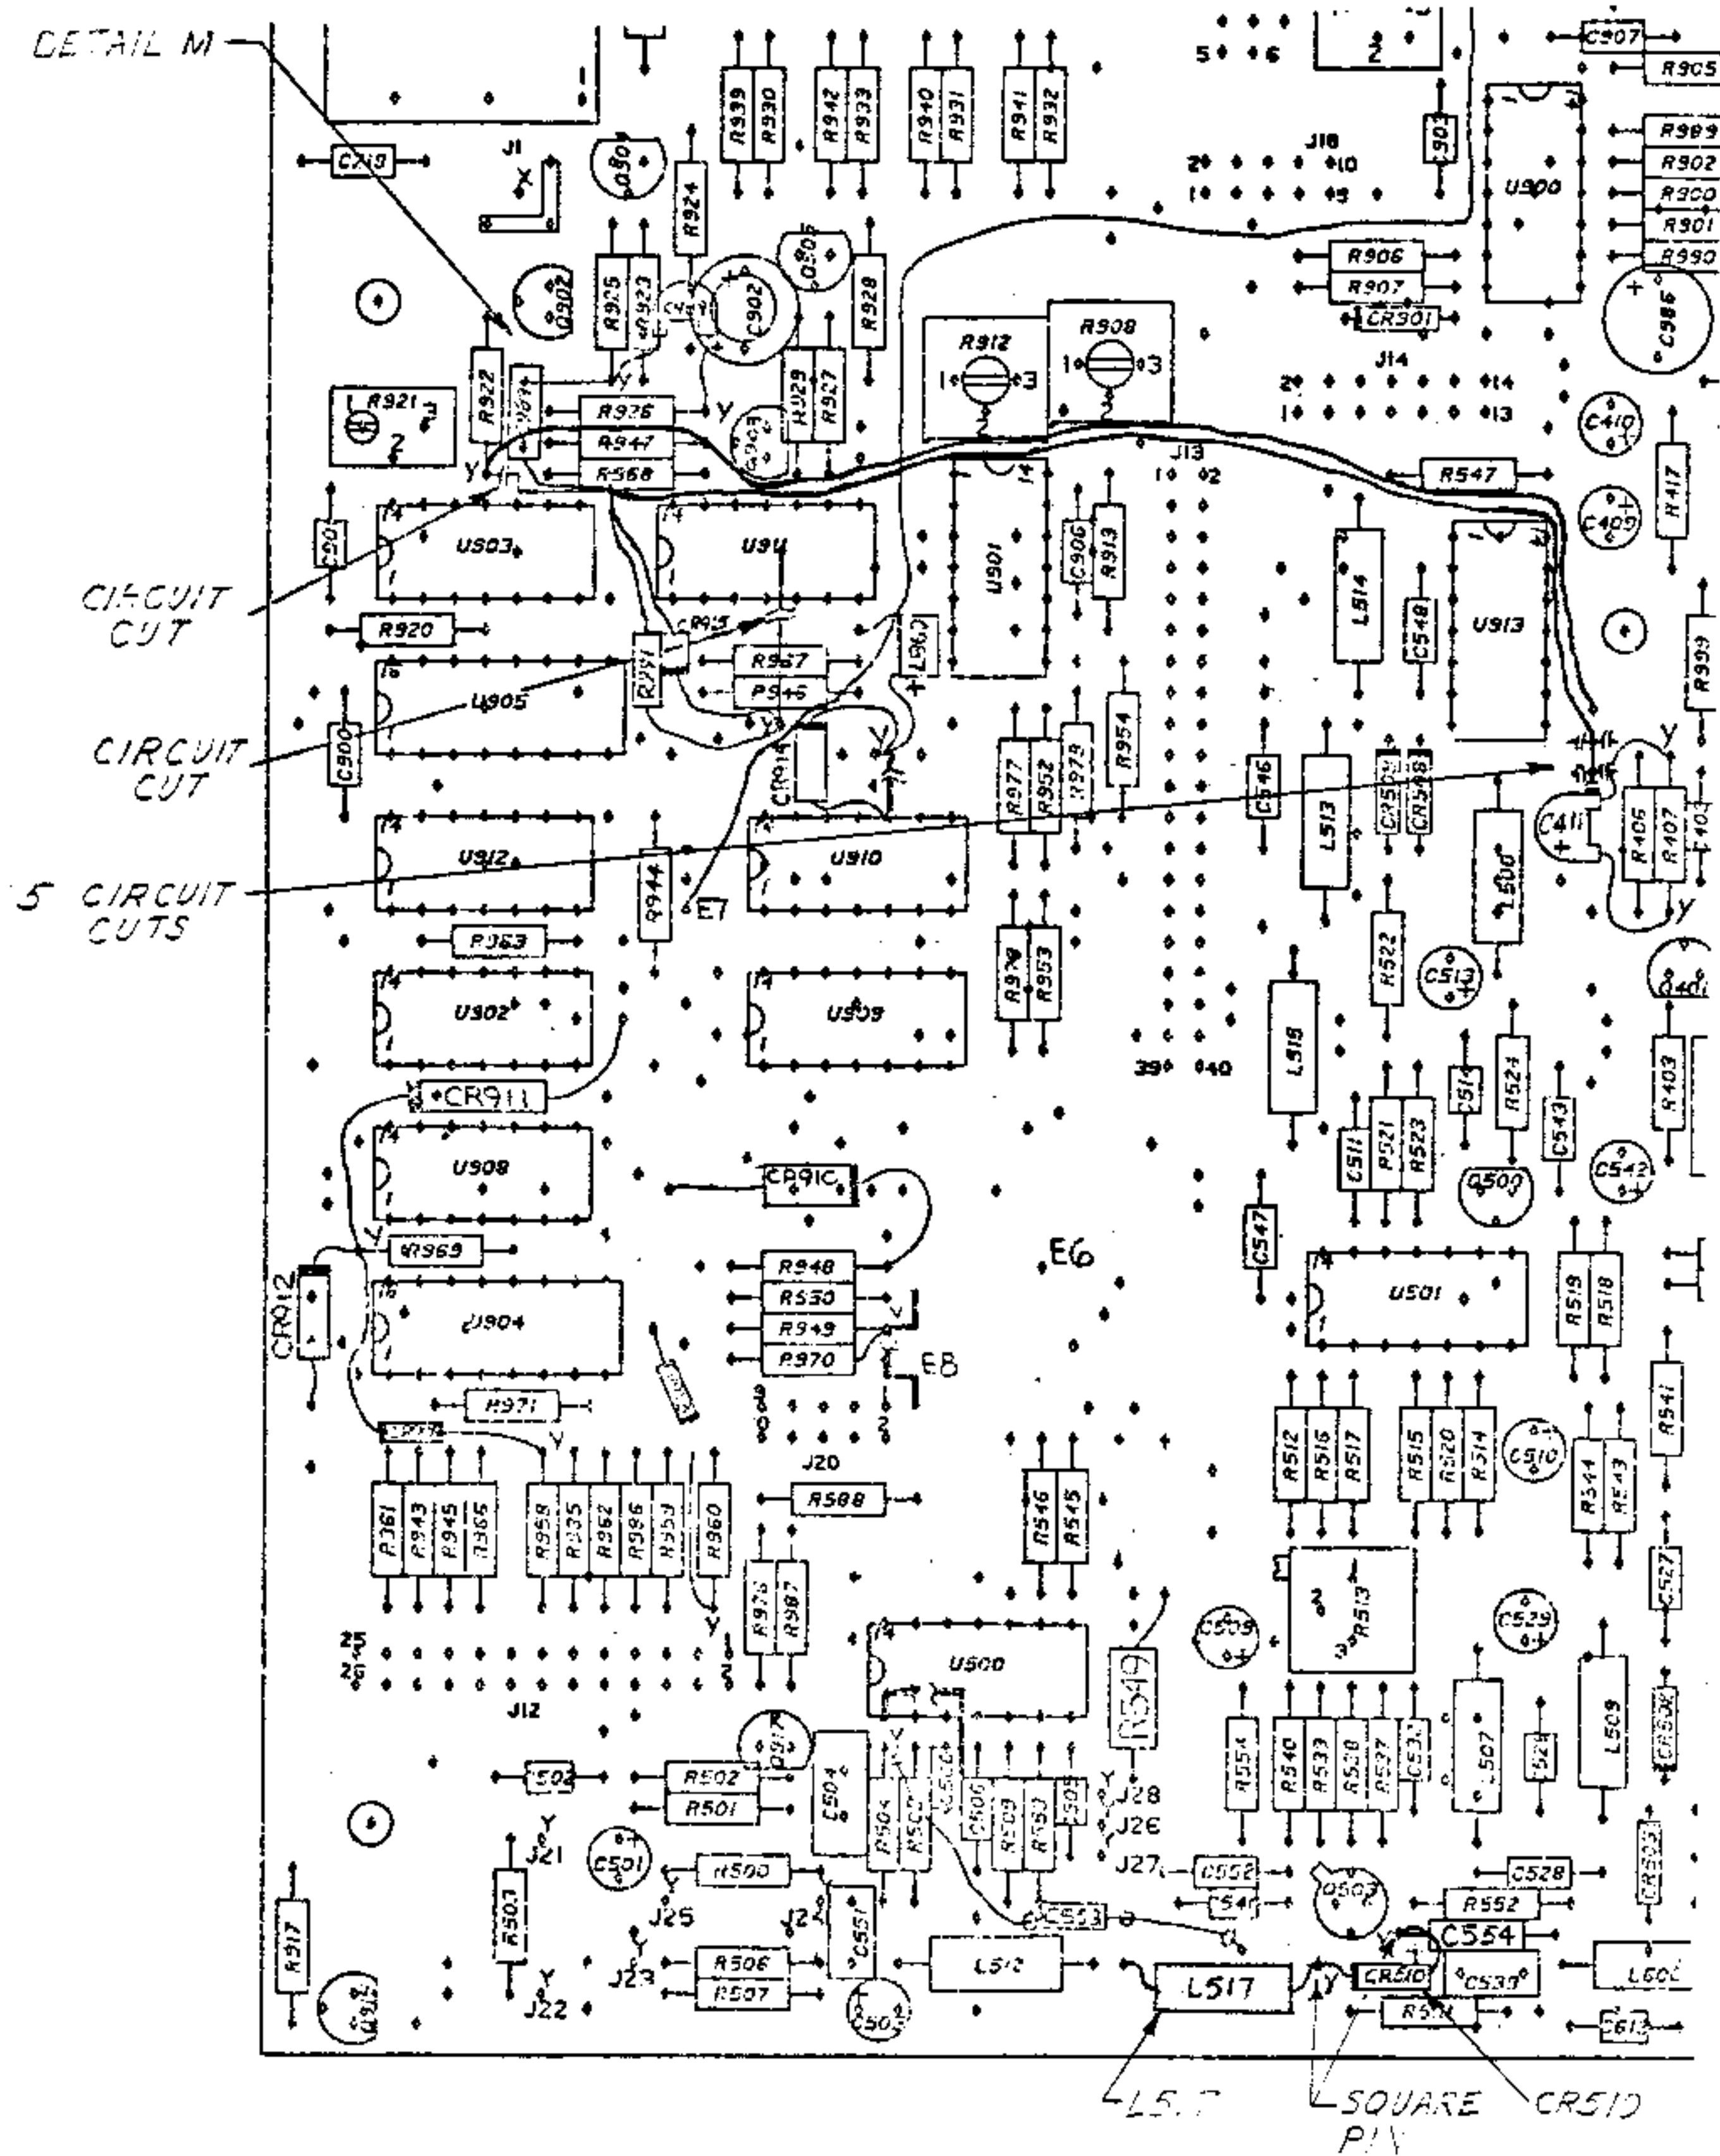
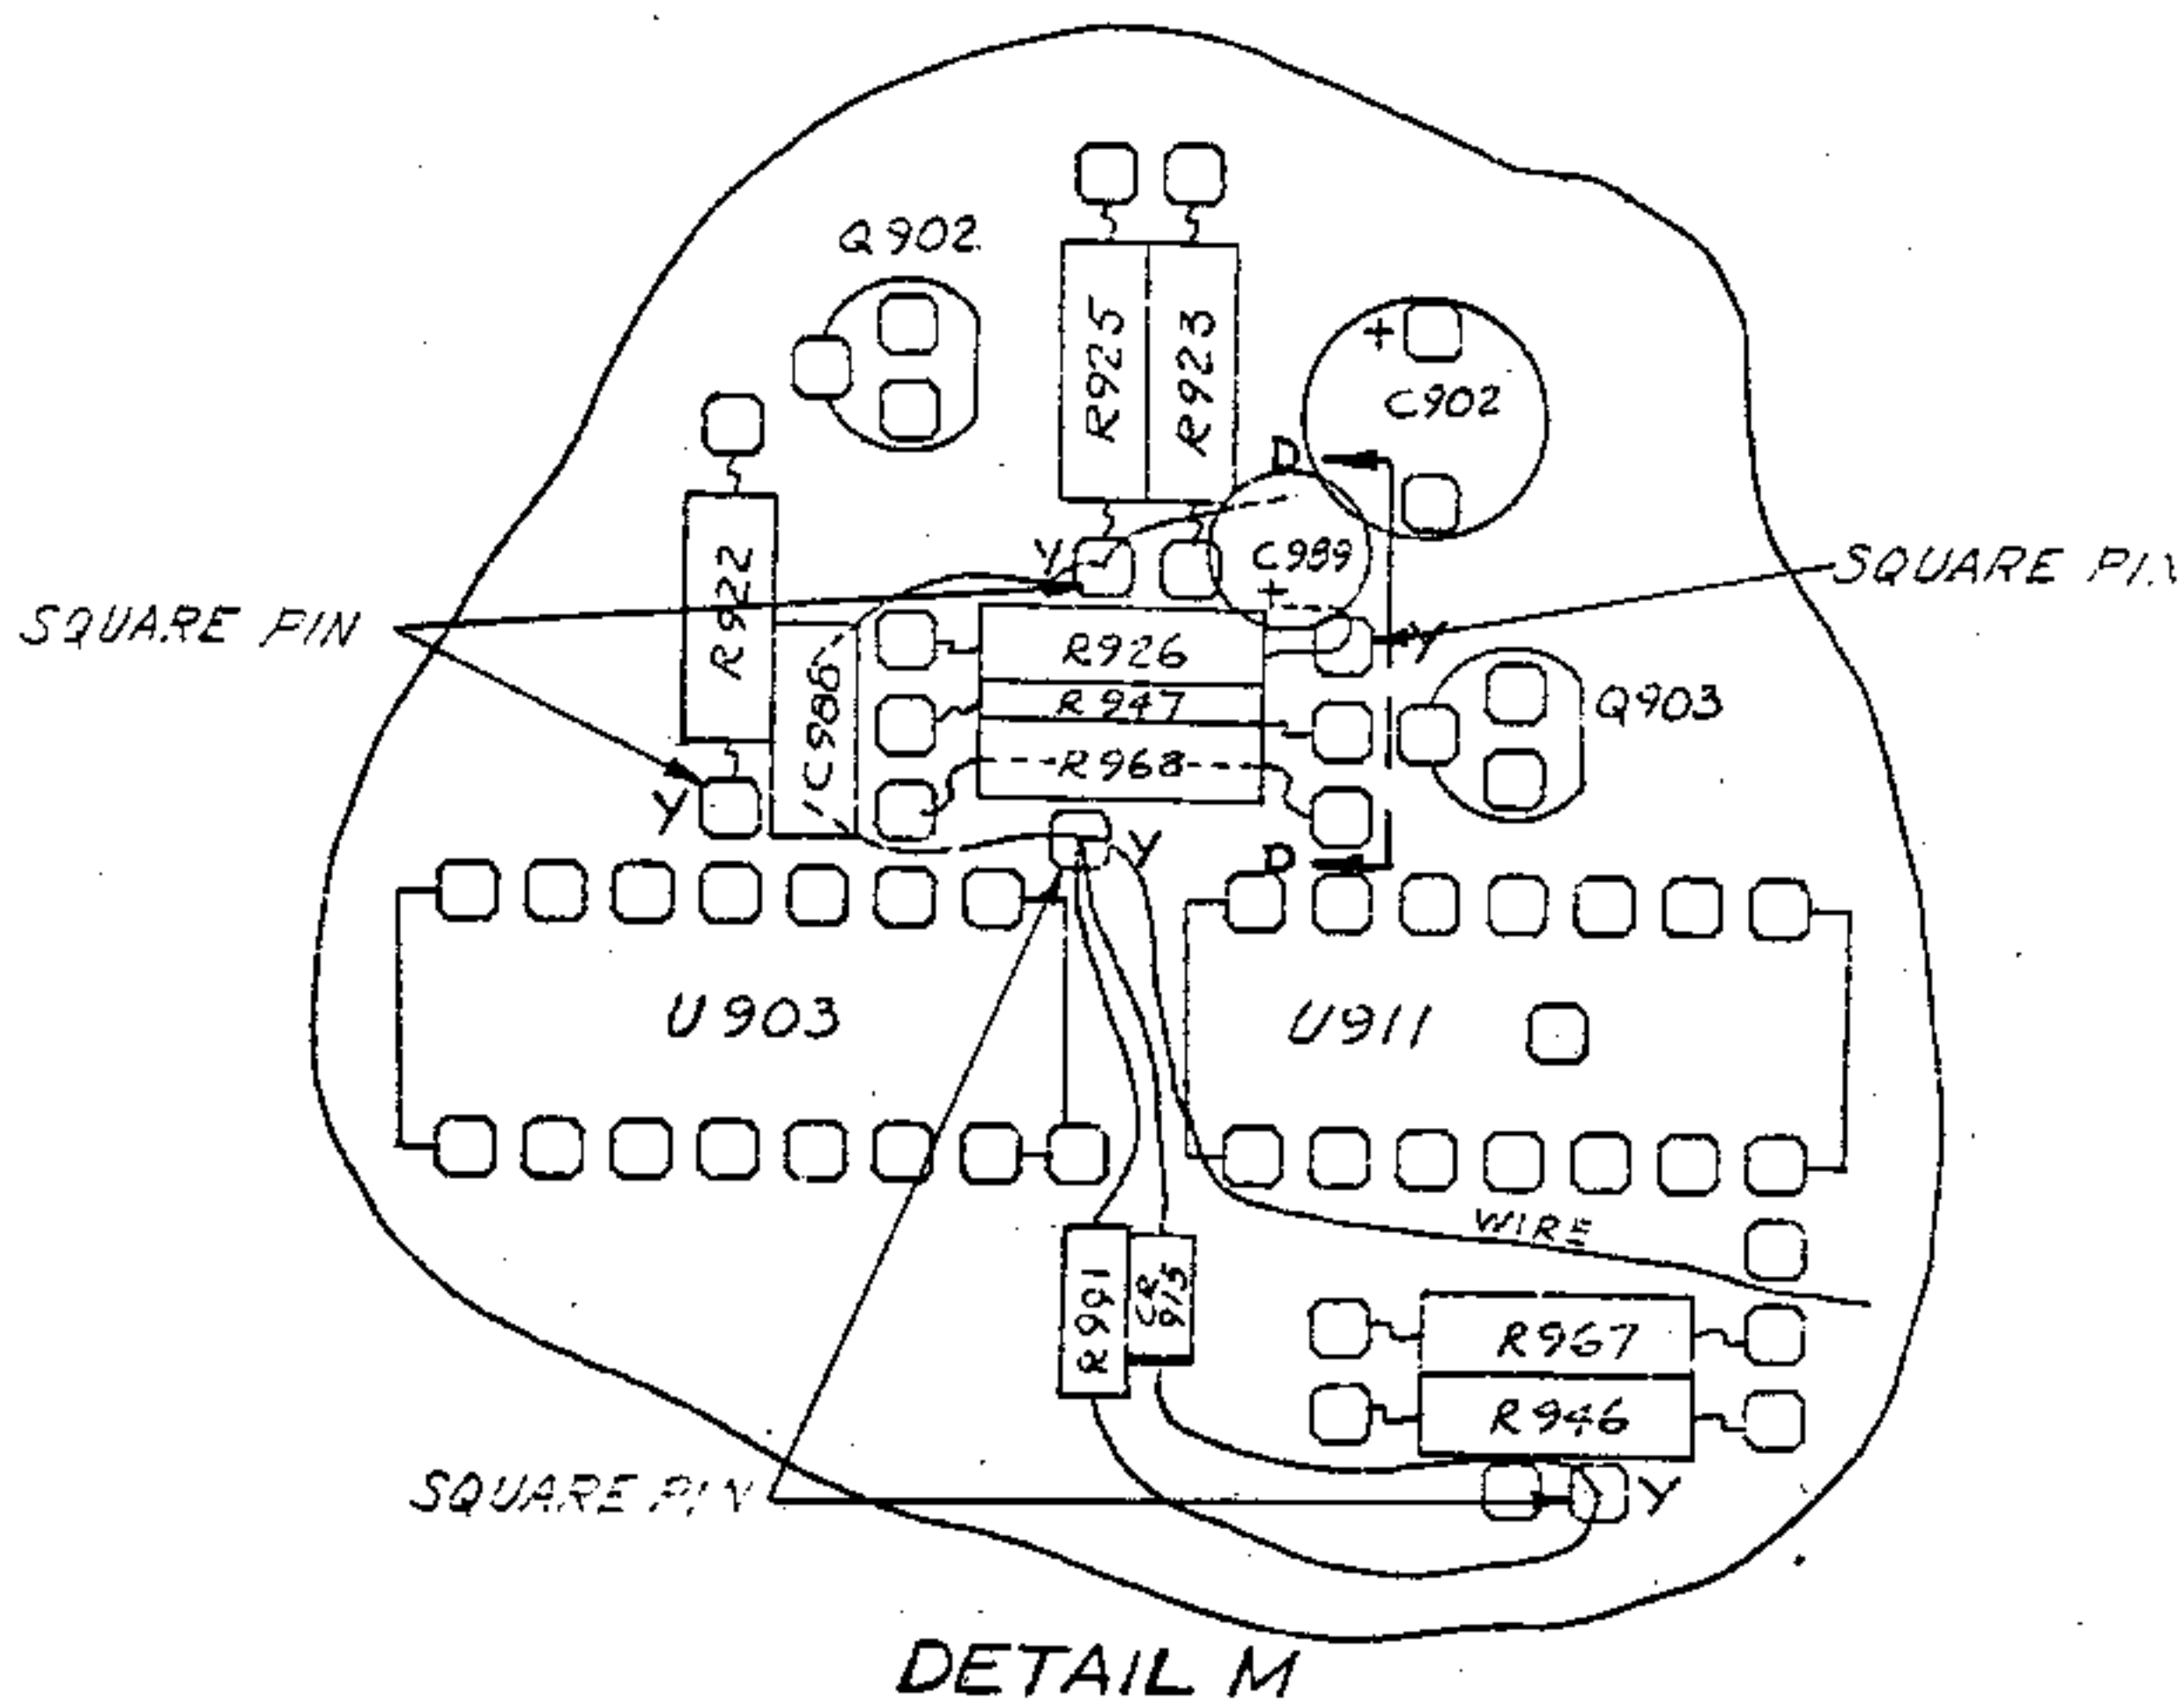
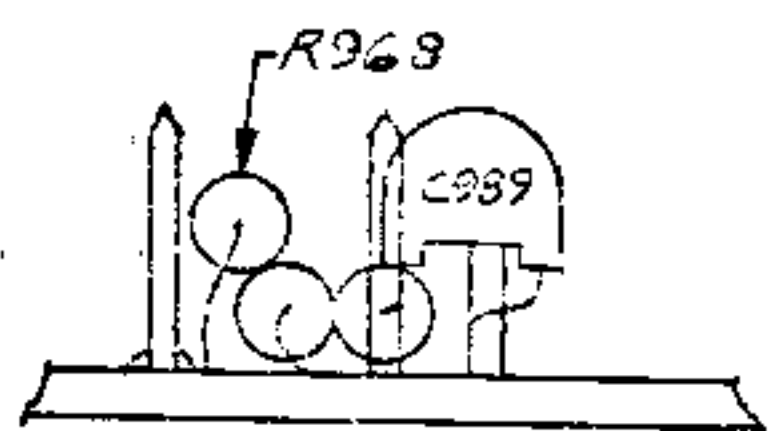
P/O Receiver-Exciter Circuit Card A3.  
Figure 1 (Sheet 2)

SECTION D-D  
ROTATED 90°  
CLOCKWISE
